FACILITY ASSESSMENT AND SPATIAL PLANNING

# LINCOLN COUNTY PUBLIC LIBRARIES

ISSUE DATE: OCTOBER 6, 2022

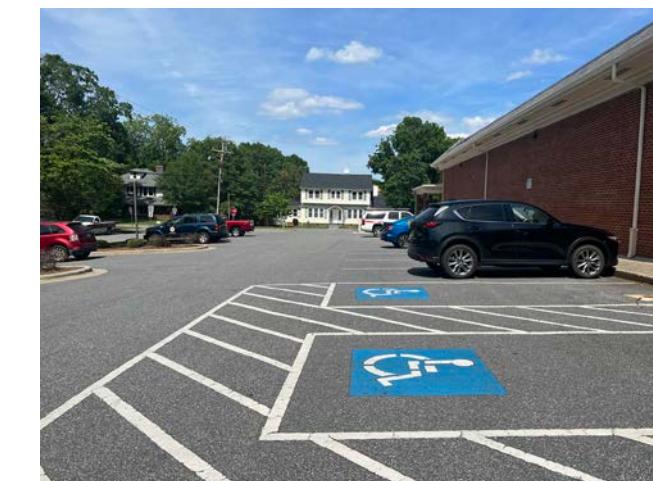
**2** **3** Parking lot and striping are in good condition

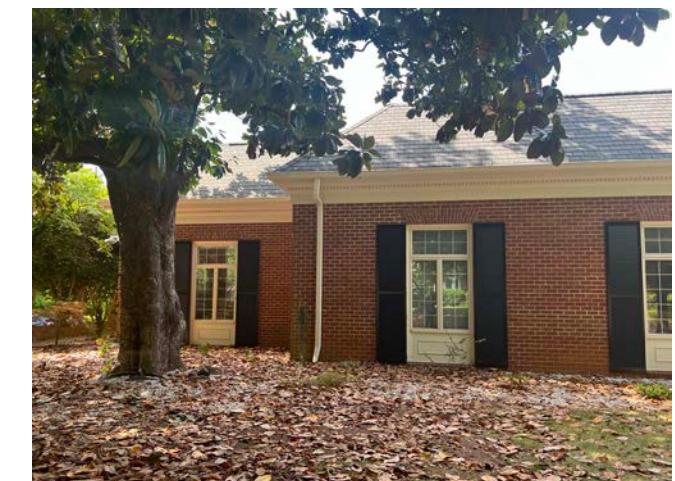
**6A** Large magnolia produces a lot of leaf litter, and often clogs gutters and downspouts

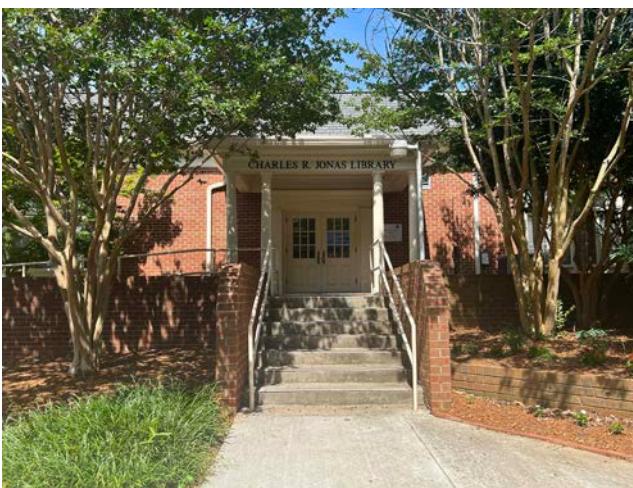
**1** Brick is in overall good condition, but could use a cleaning overall

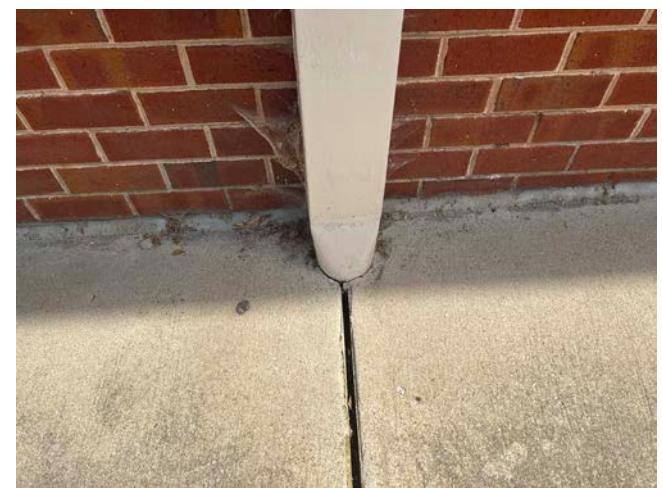
**2** Heavy caulking joints are present at the sidewalk; photo taken at north side of building at the parking lot

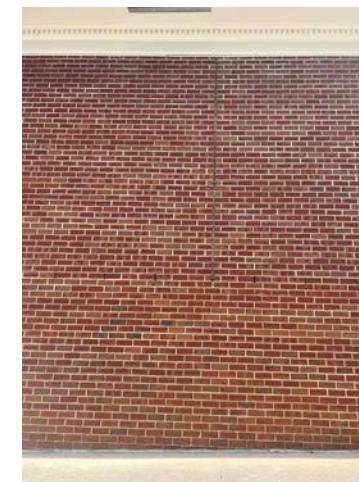
**3** Existing control joints do not extend to the building foundation

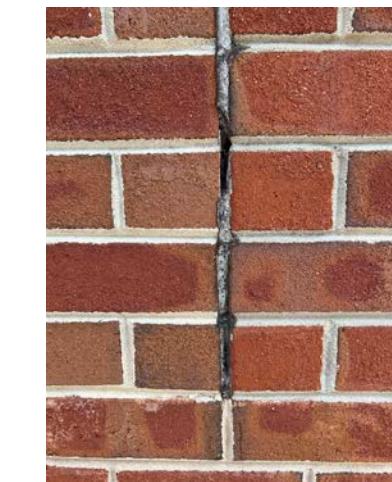
**3** Control joints need replaced

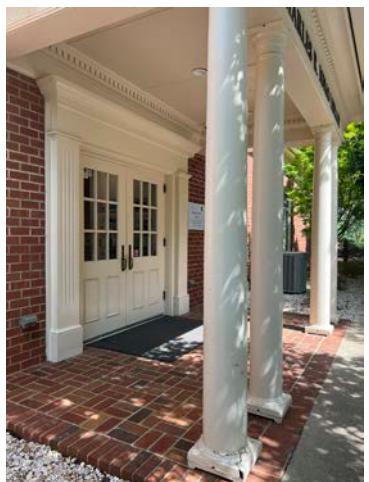
**4B** West entry soffit is frequently infested with wasps

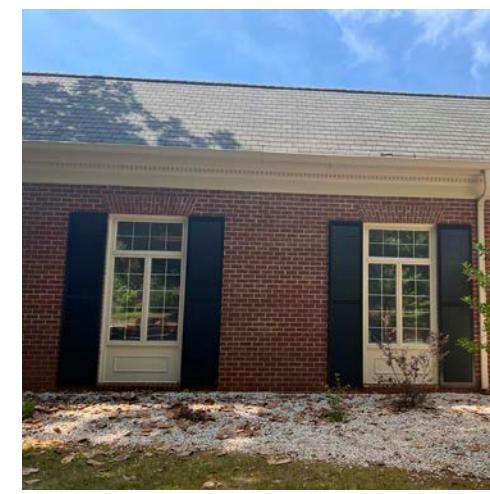
**6** Typical window conditions

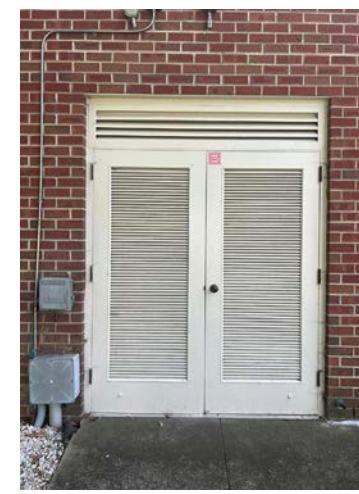
**8** Mechanical room doors

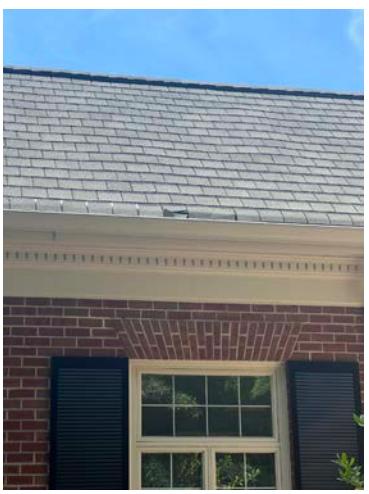
**10A** Incorrectly installed starter shingles; shingles often peel away at the edge condition

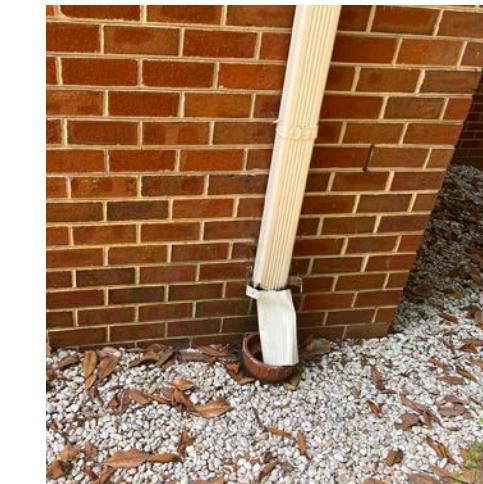
**12** Some gutter to storm water connections are damaged and need replaced

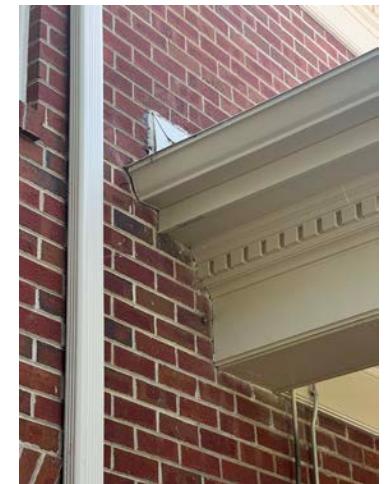
**13** Fascia are in average condition; building could use an overall cleaning

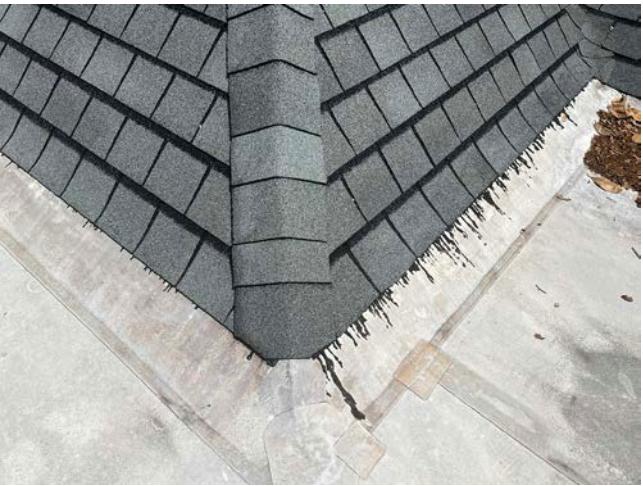
**10A** Interior side of shingle parapet; no termination flashing was used between the PVC roofing membrane and the asphalt shingles

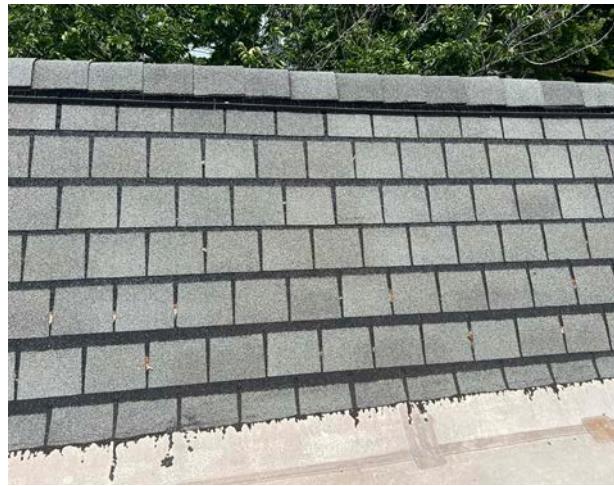
**10A** Interior side of shingle parapet; improper shingle overlap; roof ridge vent is in good condition

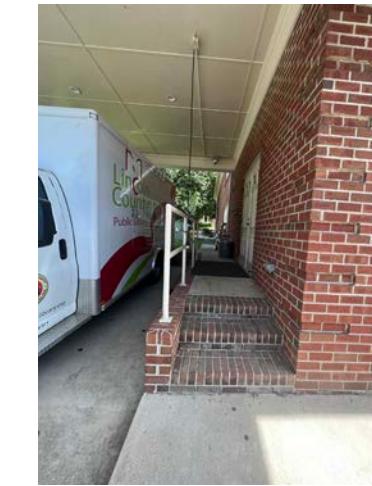
**14** Loading dock portico

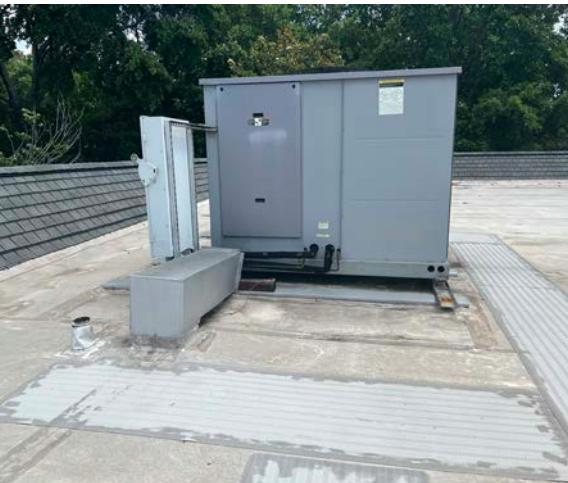
<b>10B</b>	PVC roofing was replaced in 2014 and is in average condition. Some soft spots are noticeable under foot. There is no evidence of shrinkage, cracking, or excessive ponding.
<b>DRAINS</b>	<b>11</b>	Roof drains appear to be functioning correctly. No leaks have been reported.
<b>GUTTERS &amp; DOWNSPOUTS</b>	<b>12</b>	Gutters and downspouts are in average condition. Some of the gutter to storm water connections are damaged and need replaced. Gutter guards frequently get clogged with tree debris and need cleaned out in order for the gutters and downspouts to function properly.
<b>FASCIA</b>	<b>13</b>	Fascia are in average condition; the building could use a cleaning overall.

**10B** PVC roofing is in average condition

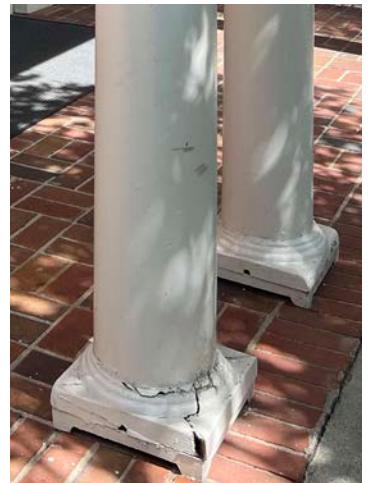
**14** The column covers at the western entrance are cracked and need replaced

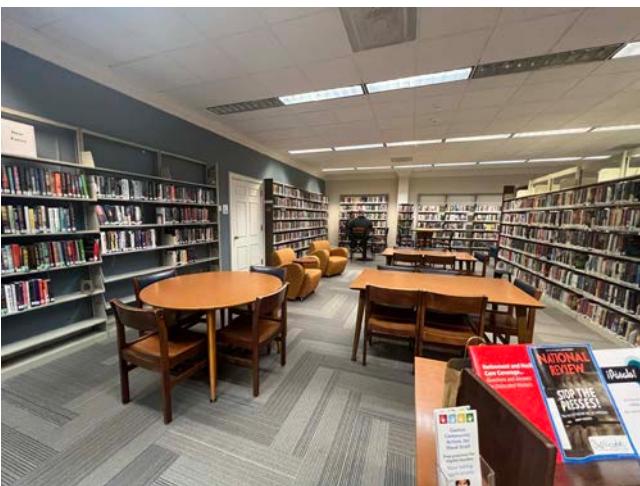
<b>112B READING AREA</b>	<b>12B</b>	Reading area interior finishes are in good condition. Reading space lacks adequate power supply for patrons. Furniture lacks convenience outlets for patrons; floor box power is occasionally available near seating areas, but power cords running to tables creates tripping hazards.
<b>112C TEEN AREA</b>	<b>12C</b>	Some of the furniture in the teen area is original to the library, is in good condition, and can be planned for refurbishment and reuse. The balance of the furniture is nearing the end of its functional and aesthetic life.
<b>113 STORAGE</b>	<b>13</b>	Table and chair storage for the community room has been re-purposed for general storage. The room is overflowing. Mechanical platforms were installed at the last renovation, and are very hard to service due to how full the storage room is.
<b>114 KITCHEN</b>	<b>14</b>	The kitchen has been re-purposed to accommodate additional storage, and is currently unusable as a kitchen.

12B Reading area

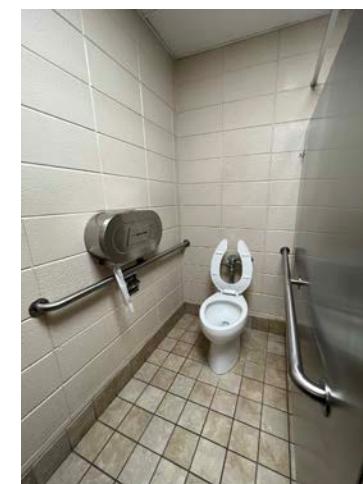
**17** The men's restroom has many code and ADA related issues

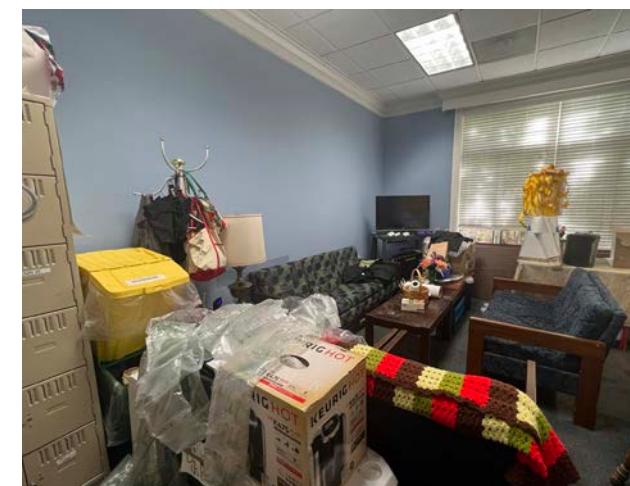
**21A** Staff lounge kitchenette is outdated and being used as additional storage space; furniture is very worn

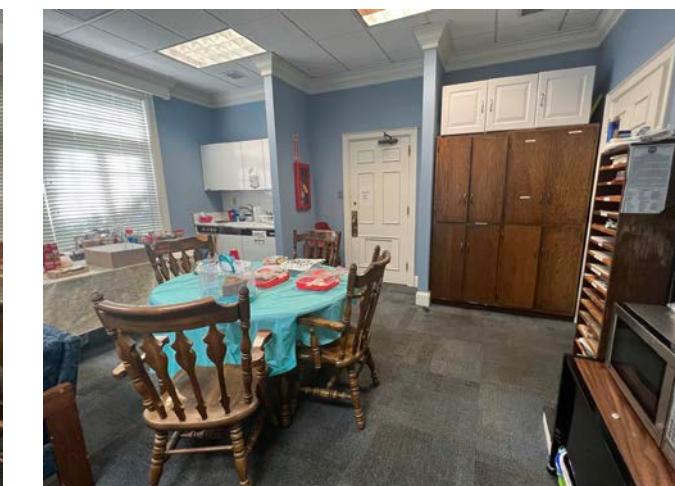
**21B** The range has been disconnected by facilities; the upper wall cabinets don't appear to be attached to the wall

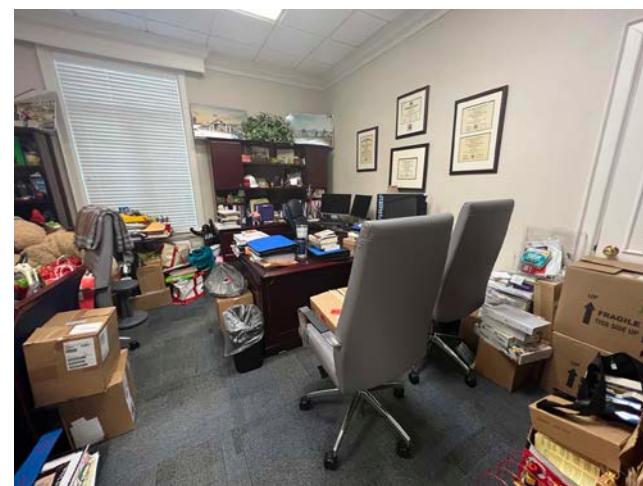
**25** Office is being used as additional storage space

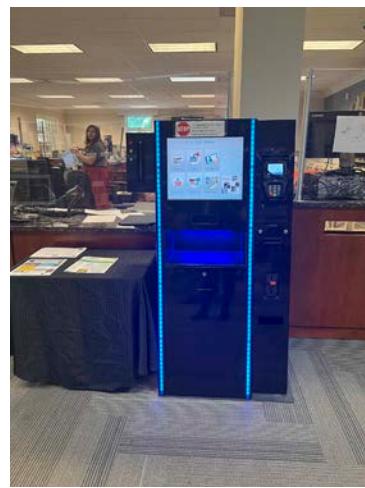
**49** Self check appears to be in good condition

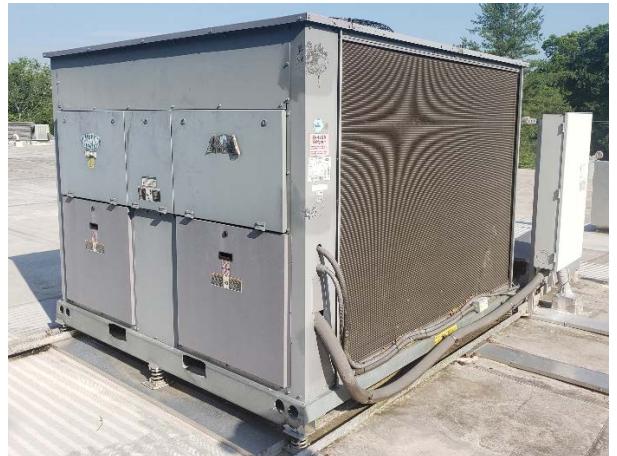
Air Cooled Condensing Unit

The 14,700 sq ft building uses one air-cooled condensing unit and three individual split system heat pumps to condition the air in the space, achieving a cooling density of 306 square feet/ton. The 40-ton air-cooled condensing unit was installed in 2012, and the three splits (3-ton, 2-ton, and 3-ton) were installed in 2011, for a total of 48 tons in cooling capacity. The air-cooled condensing unit is in fair to poor condition. The three additional heat pumps are in good condition; however, with a life expectancy of 15-18 years, in five years, they will be nearing the end of useful service life.

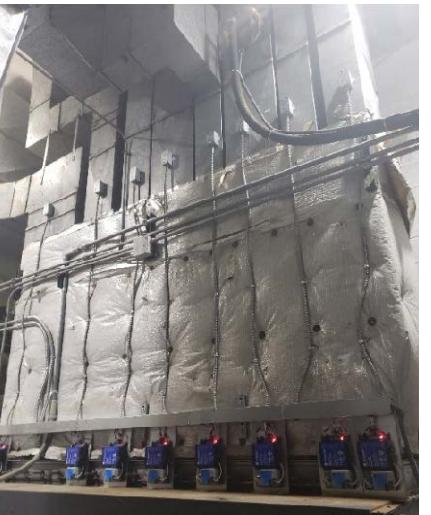
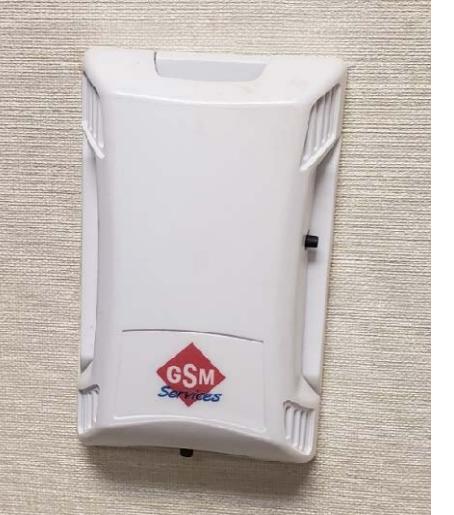
Figure 3: Thermostat & Controls

The current thermostats were replaced as part of a 2021 AHU controls system upgrade.

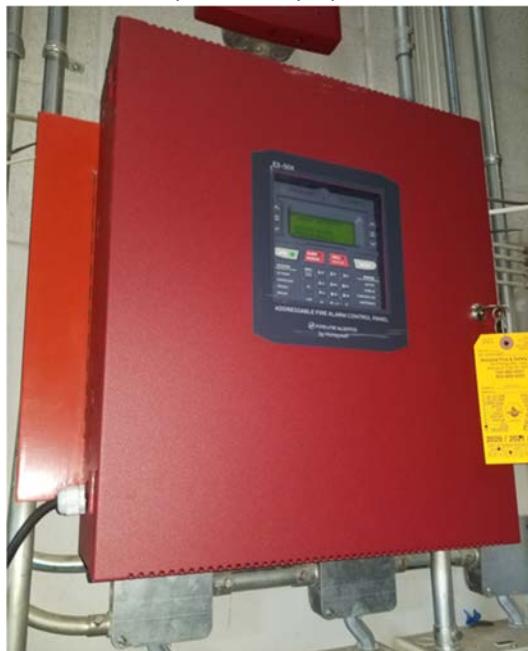
Figure 10: Fire Alarm Panel

The existing fire alarm system was replaced within the last 2 years. The control panel is located in the exterior accessible mechanical closet. Shop drawings and coordination with the manufacturer/ provider of the existing system will be required to determine existing systems limits and expandability options.

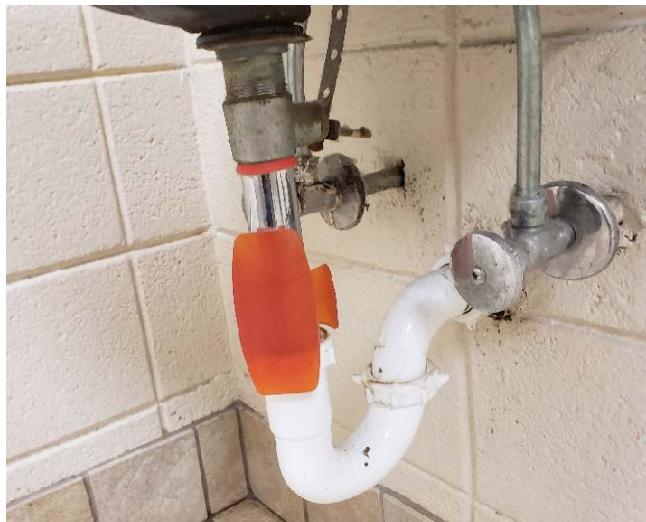
Figure 15: P-Traps

Sanitary traps and vents are in good condition, with toilet lavatories needing minor attention for cleaning and P-trap connection alignment verification. It is noted by observation and per maintenance manager, that no wall cleanouts are present and there are no floor cleanouts within the library.

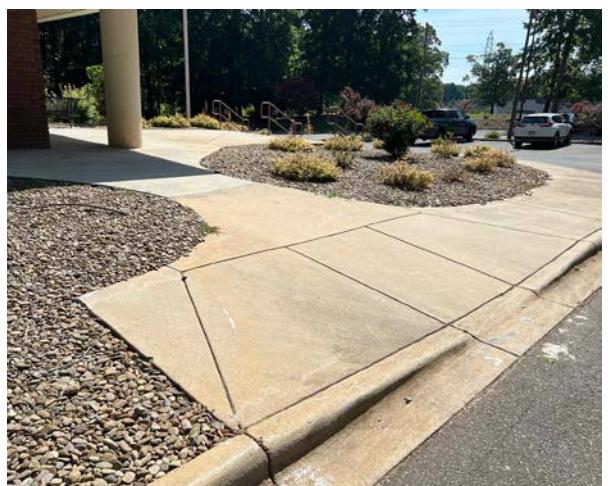
1 The sidewalks and curbs are in good condition

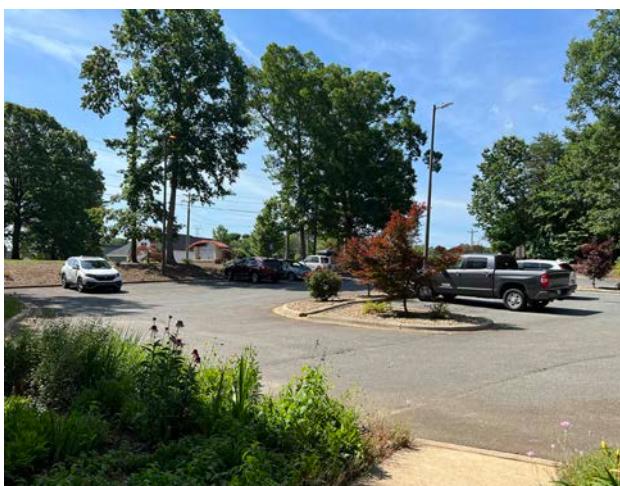
2 The surface of the parking lot is in good condition with only minor blemishes

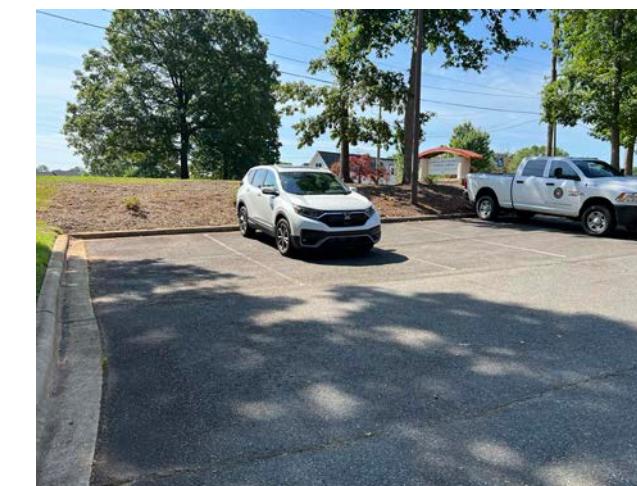
3 The parking lot striping is faded, the parking spaces are not clearly visible

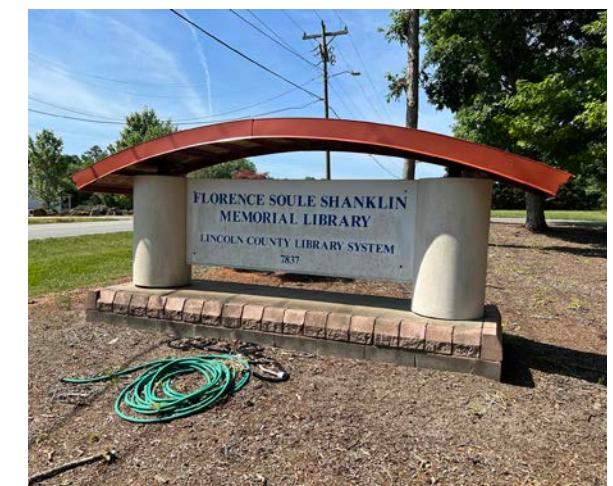
5 A monumental sign is located on Fairfield Forest Rd

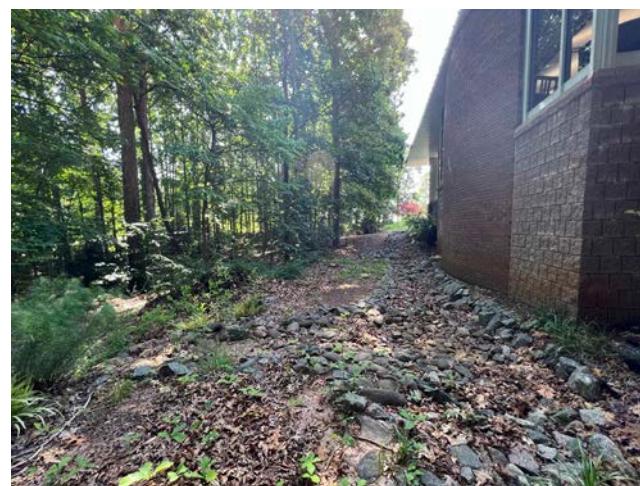
**6A** The trees at the north and north east side of the building make it difficult for the ground to dry out after it rains / snows.

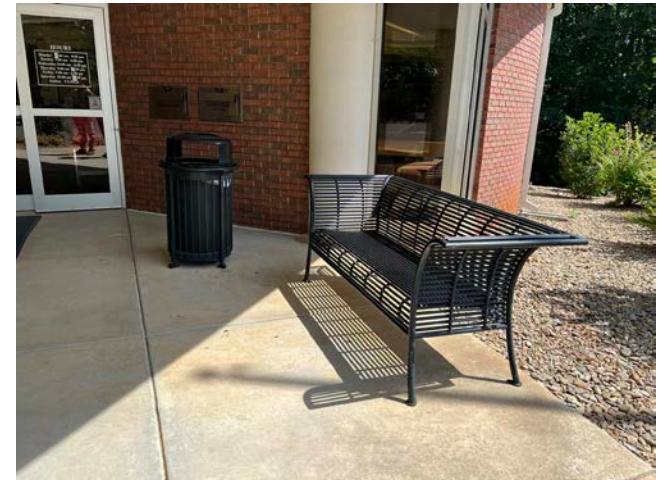
**7** Site furnishings are in good condition

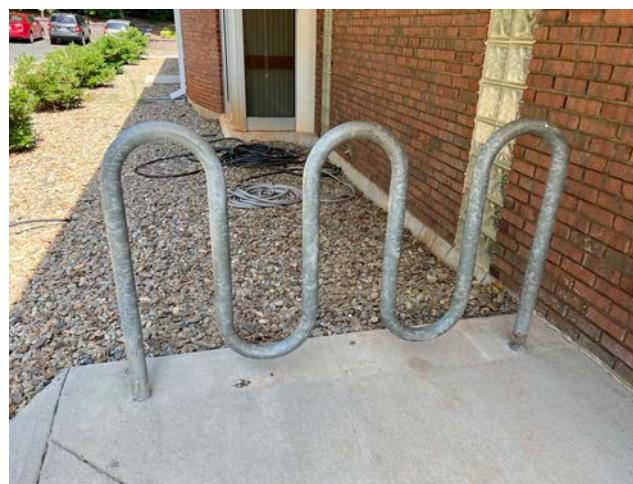
**8** Bike rack is worn but in working condition

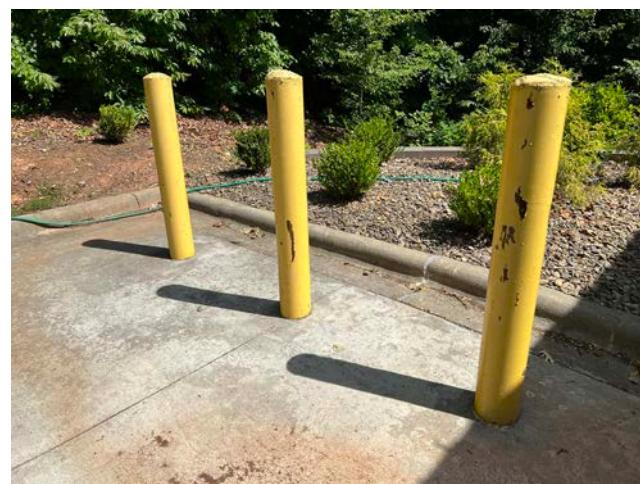
**10** Bollards are functional, but could use a fresh coat of paint

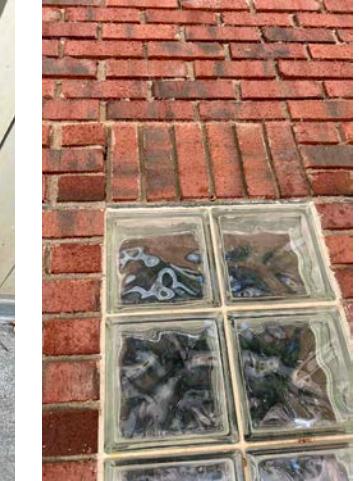
<b>2B</b>	Raked mortar joints contribute to moisture infiltration, as each joint becomes a ledge that holds water.

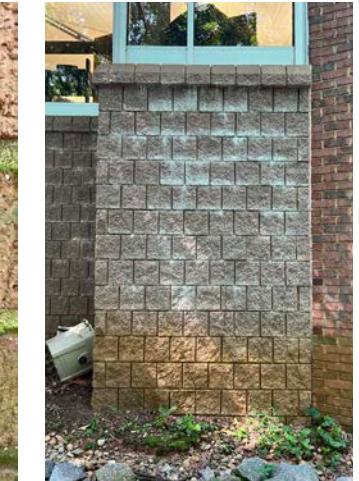
<b>4D</b> No flashing or weep holes are present at the sill detailing of the storefront

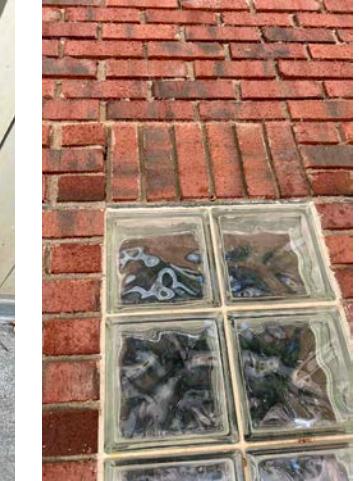
<b>4</b>	No expansion or control joints were observed.

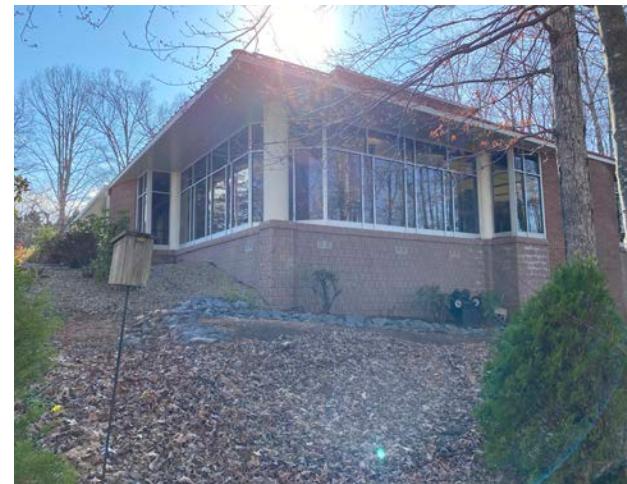
**7** The crawlspace vents appear undersized and perhaps have airflow restrictions

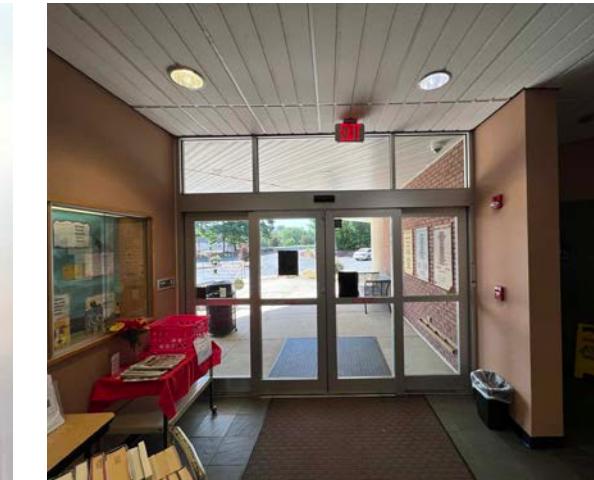
**9** Primary entrance doors are in good condition

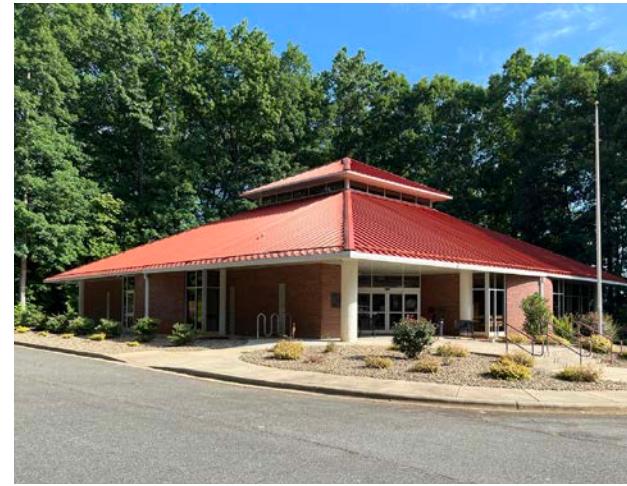
**12** **13A** Standing seam metal roof appears to be in good condition; gutters and downspouts are provided near the entry

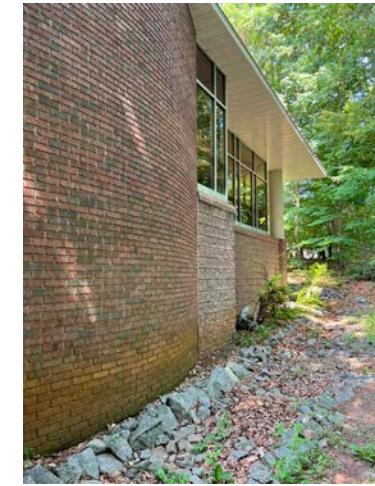
**13B** Staining on existing brick suggests that rainwater splashes back onto the building

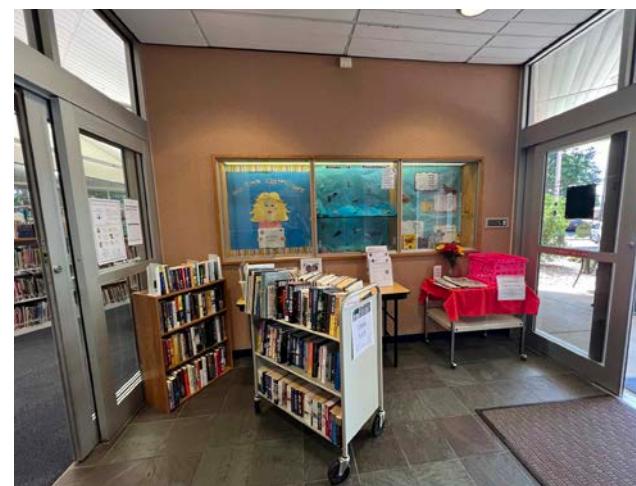
**0** Interior doors are left open, and let conditioned air out of the building; the exterior doors open and close unnecessarily from patrons moving about the lobby area

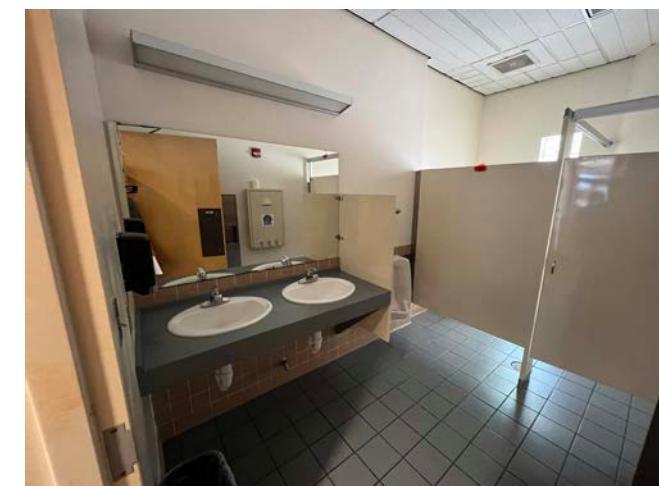
**1A** There are exposed pipes below the sink

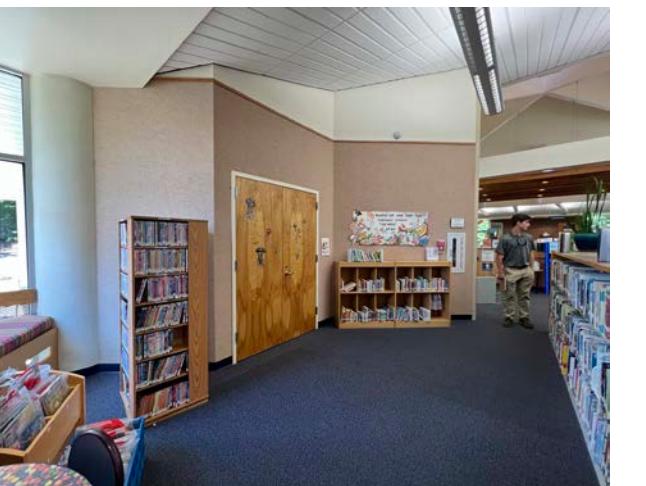
**15F** Book drop access doors; this room was not observed

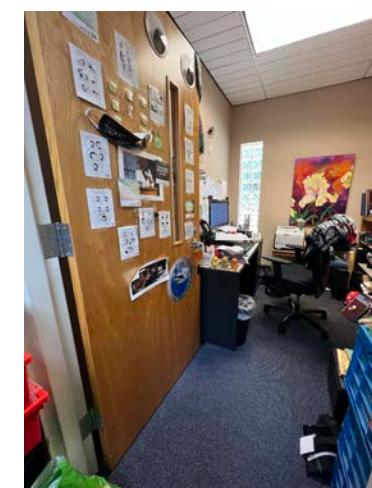
**8** Current furniture arrangement impedes code required door clearance

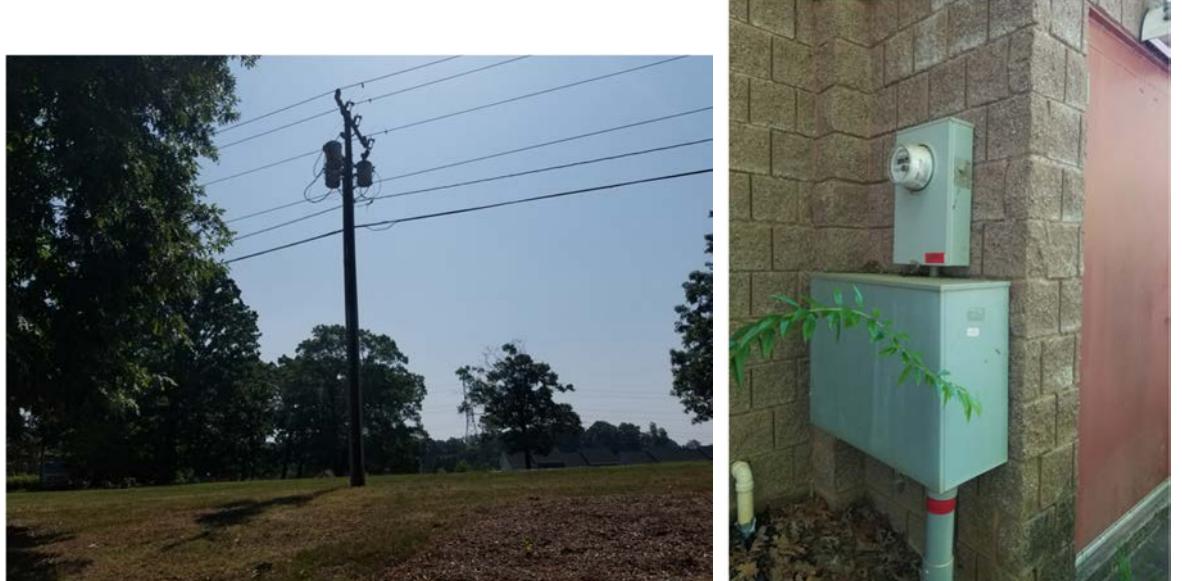
Figure 7: Electrical Utility Equipment

The existing electrical service is fed from a pole mounted transformer located on Fairfield Forest Road. The secondaries from the transformer are fed underground to a building mount meter found on the exterior of the building. Coordination with the existing utility company will be critical for any expansion to determine if the existing utility needs to be replaced or an additional service will need to be provided to the site.

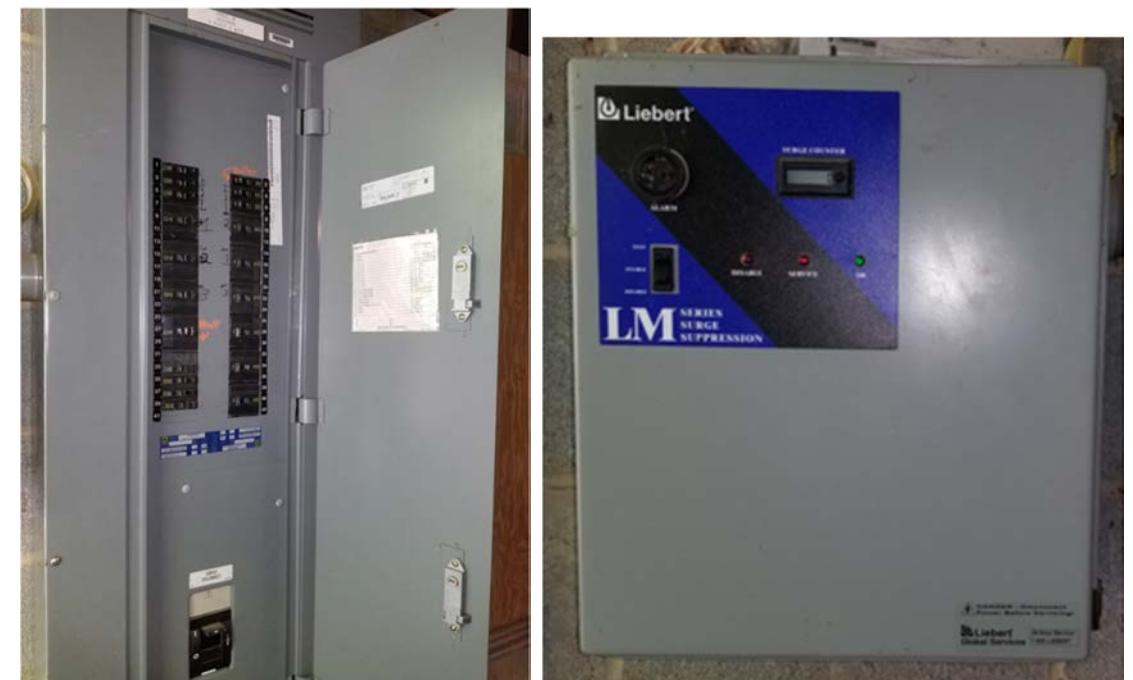
Figure 8: Panel M

Panel M is a 300A 208Y/120V, 3-Phase, 4-wire main distribution board feeding all other branch panels in the building. The panel is located on the lower level/ crawl space for the building. Panel M main breaker is service entrance rated and the panel has an external Surge Protection Device located adjacent to the panel. The existing main panel will require metering to determine the existing load on the equipment and if the Panel would need to be replaced in its entirety.

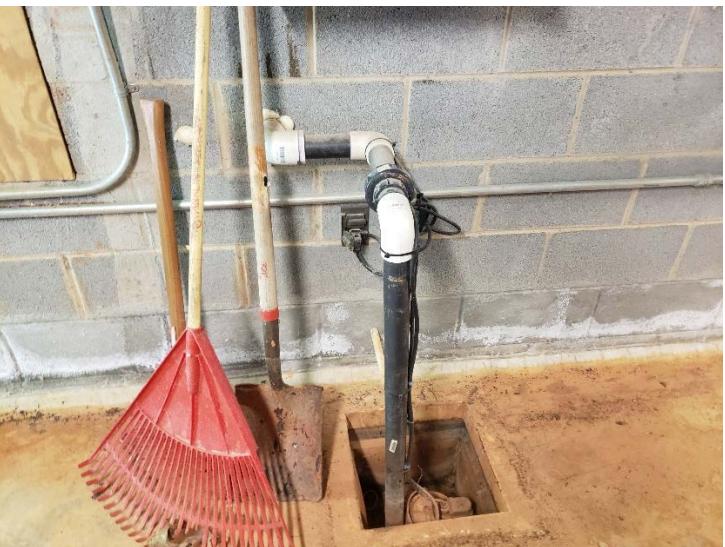
Figure 16: Sump Pump

Sanitary traps are and vents are in good condition, while the sump pump is in fair condition, though nearing the end of life (per maintenance, the sump pump was installed at the high side instead of the low side). In the restrooms, ADA required protection is in place.
