FACILITY ASSESSMENT AND SPATIAL PLANNING

# LINCOLN COUNTY PUBLIC LIBRARIES

ISSUE DATE: OCTOBER 6, 2022

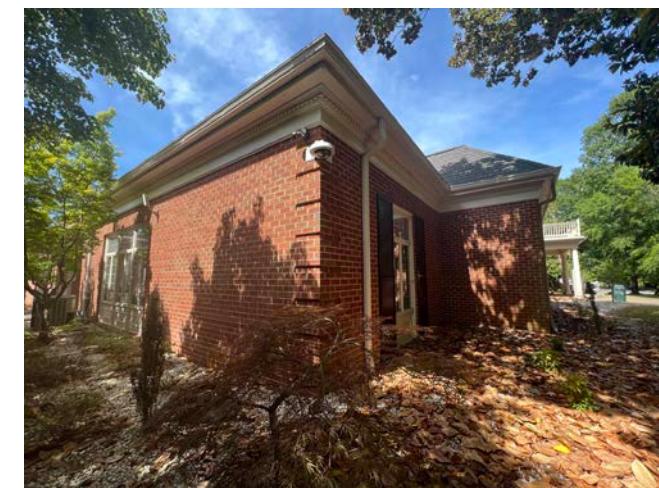
<b>6B</b>	The landscaping along the southern, eastern and western facades of the building were previously pruned and/or removed to aid in maintenance efforts. While easier to maintain, the building appears bare.
	<b>6C</b>	The landscaping at the courtyard is in good condition.
<b>SITE FURNITURE</b>	<b>7A</b>	While no site furniture is provided, there is frequent loitering at the W. Main St entrance.
	<b>7B</b>	Courtyard is frequented by the homeless, and is not well lit at night. This creates an unsafe environment after dark.
	<b>7C</b>	Trash bins are visible at the library's parking lot entrance.
	<b>7D</b>	Book drop; able to function as a drive up book drop if parking lot is entered from N High Street.
<b>BIKE RACKS</b>	<b>8</b>	Bike racks are in average condition.
<b>EXTERIOR STORAGE</b>	<b>9</b>	At the time of the site visit, the Library had a storage POD rental at the corner of the parking lot.

**6B** Building base looks bare due to overly pruned or removed landscaping

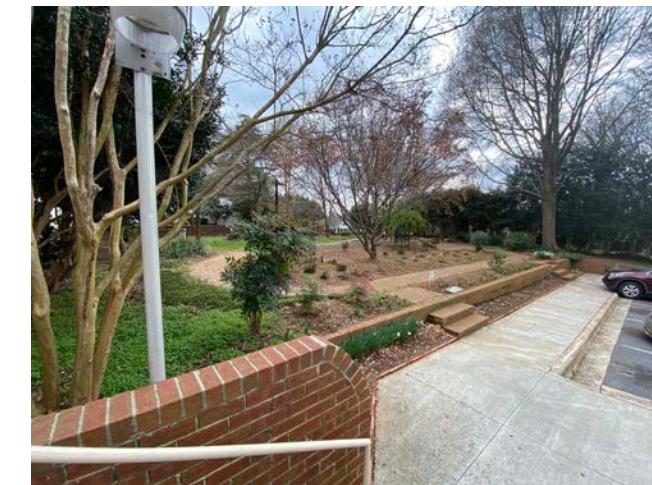
**6C** Courtyard landscaping

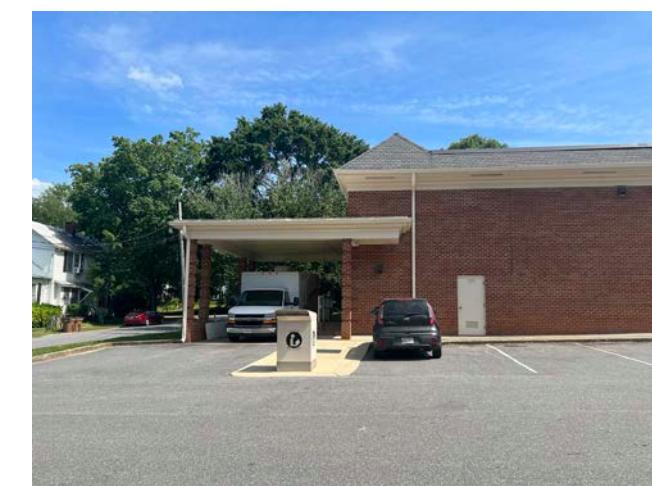
**7D** Book drop and loading dock

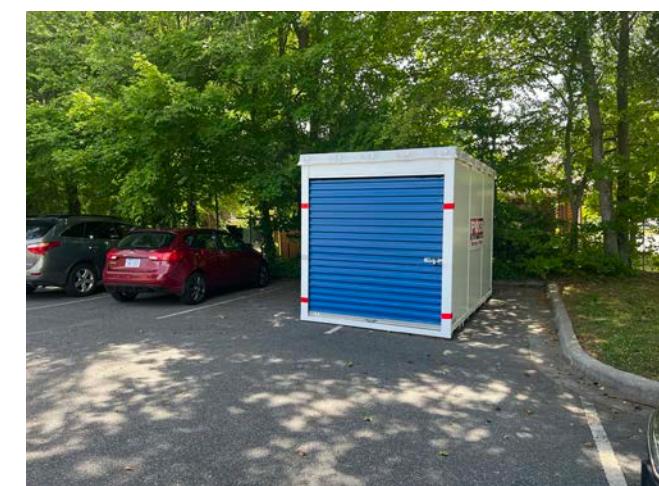
**9** PODS storage

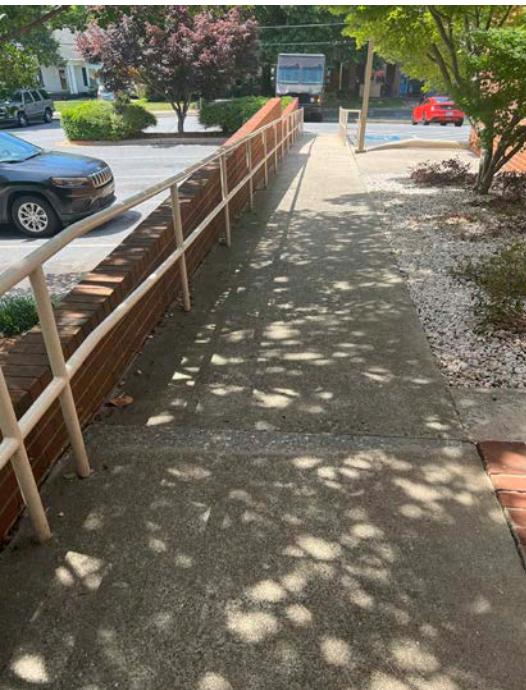
**1A** There is an accessible route from the ADA parking spaces to the primary entrance on the east side of the building. The slope of the accessible route was unable to be determined at the time of the assessment. A survey should be conducted to confirm that the slope of route does not trigger ramp requirements, as the existing conditions do not comply with ADA ramp requirements. No signage has been provided at the southern entrance to indicate that an accessible route has been provided elsewhere.

**1A** Accessible route

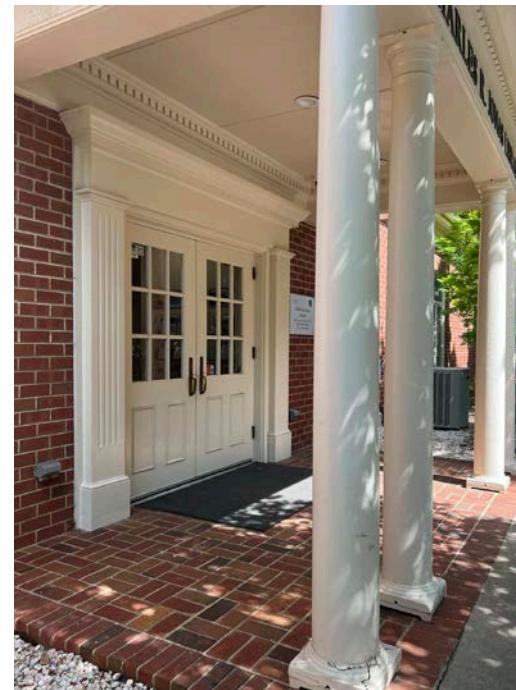
**1B** Building entrance along accessible route

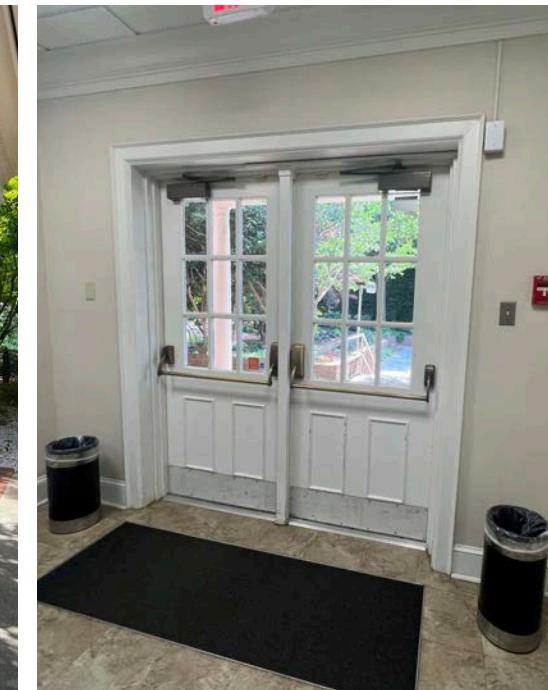
**1B** Non-ADA compliant push hardware on entrance

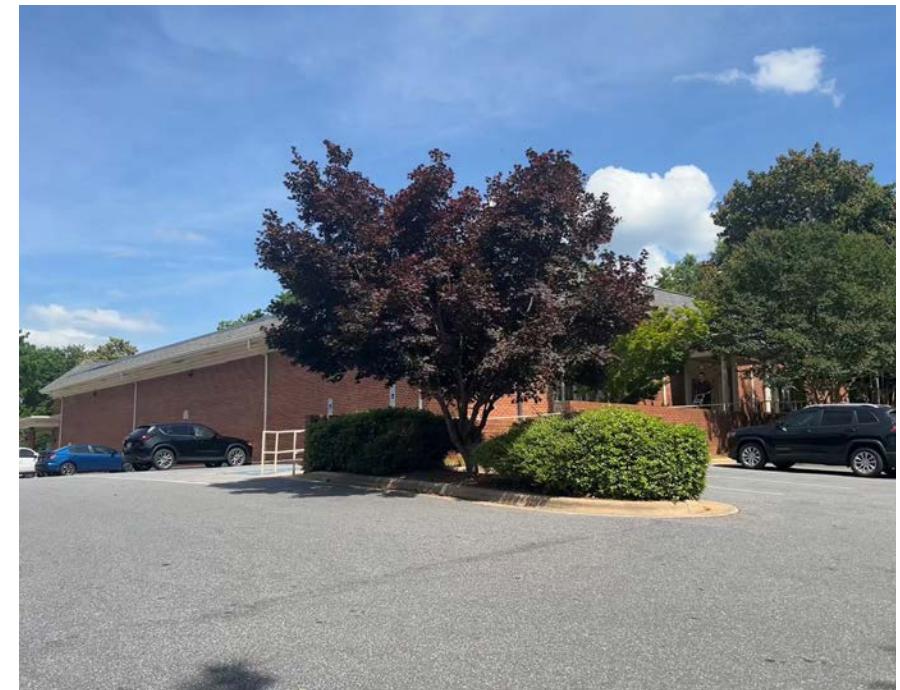
**2A** An adequate number of ADA Parking spaces are provided near the accessible entrance. The dimensions of the ADA parking spaces need to be field verified to confirm compliance for 1 accessible stall and 1 van accessible stall.

**2B** Signage has been mounted on the building to indicate the ADA parking spaces.

**2A** **2B** ADA parking spaces with wall mounted signage, located near accessible route

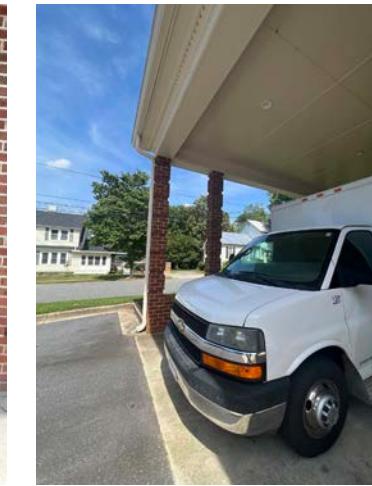
**14** Porticos are in average condition overall. Facilities reports that the railing at the southern facade along W Main St is a maintenance nuisance. The railing is in constant need of cleaning, painting, and debris removal. The column covers at the western entrance are cracked and need replaced.

**14** Loading dock portico

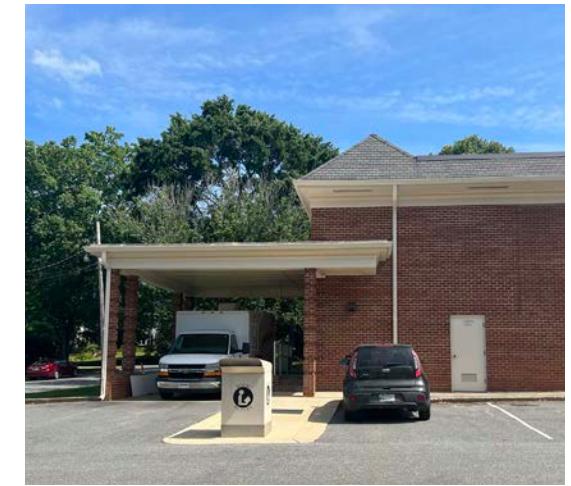
**14** Loading dock portico

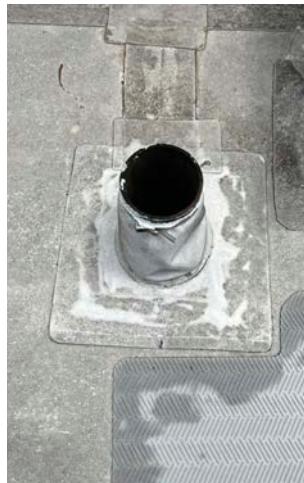
<b>10B</b>	PVC roofing was replaced in 2014 and is in average condition. Some soft spots are noticeable under foot. There is no evidence of shrinkage, cracking, or excessive ponding.
<b>DRAINS</b>	<b>11</b>	Roof drains appear to be functioning correctly. No leaks have been reported.
<b>GUTTERS &amp; DOWNSPOUTS</b>	<b>12</b>	Gutters and downspouts are in average condition. Some of the gutter to storm water connections are damaged and need replaced. Gutter guards frequently get clogged with tree debris and need cleaned out in order for the gutters and downspouts to function properly.
<b>FASCIA</b>	<b>13</b>	Fascia are in average condition; the building could use a cleaning overall.

**10B** Roof vent condition; no leaks have been reported

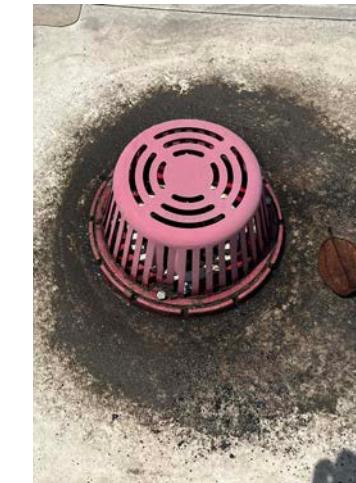
**11** Roof drains appear to be functioning correctly

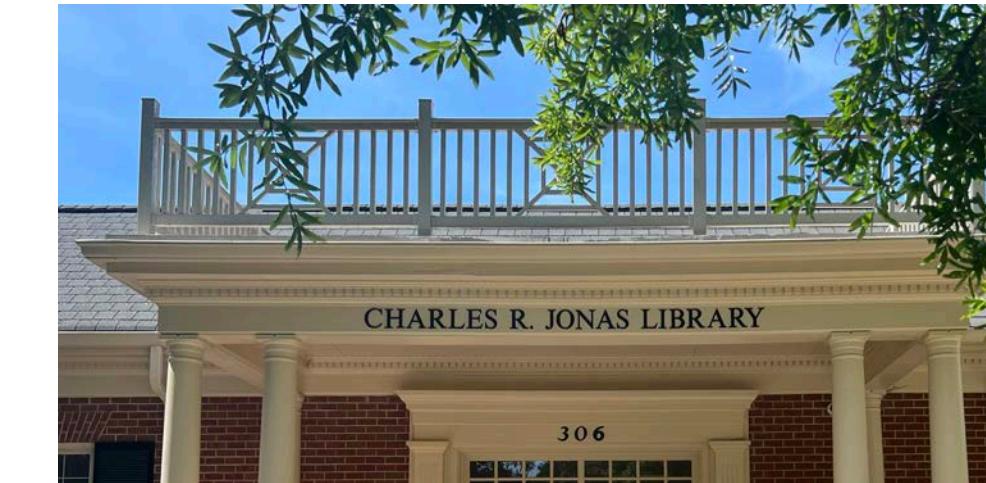
**14** Railing at portico along W Main St is a maintenance nuisance; the railing is in constant need of cleaning, painting, and debris removal

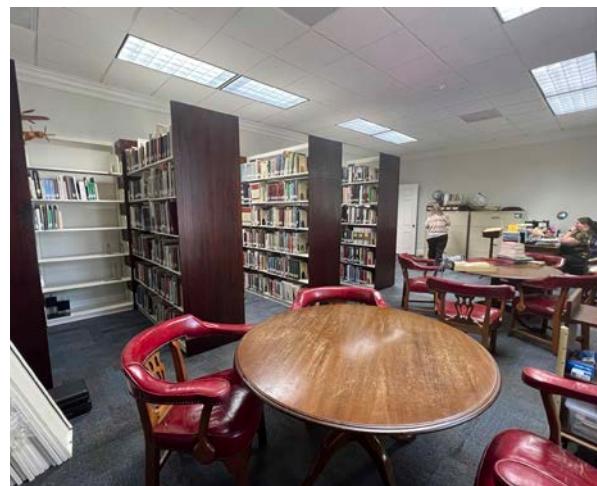
<b>105 LOCAL HISTORY</b>	<b>5</b>	The local history room utilizes shelving along the wall that creates small alcoves. The alcoves do not comply with ADA turning radius requirements. The furniture in this space is very worn and uninviting.
<b>106 MECHANICAL</b>	<b>6</b>	The air handler in the mechanical room is the original unit installed when the library was built; the old controls are no longer in service, and were recently replaced. There is no way to remove the existing air handler without demolishing it inside of the mechanical room, and then removing it in pieces. The fire alarm system was recently replaced.
<b>107 STAIR</b>	<b>7A</b>	Stair Entry. Stair provides access to storage mezzanine and lower level storage room that is currently being used as additional work room space. While the mezzanine and lower level are closed to the public, these areas are not accessible to staff members with mobile disabilities. There is no elevator or LULA lift.

5 Local history room

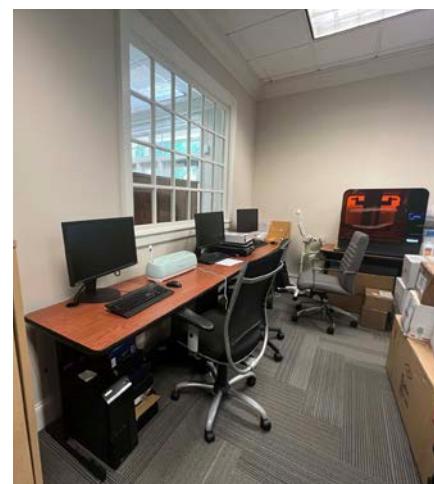
2A Computers and 3D printer at the media center

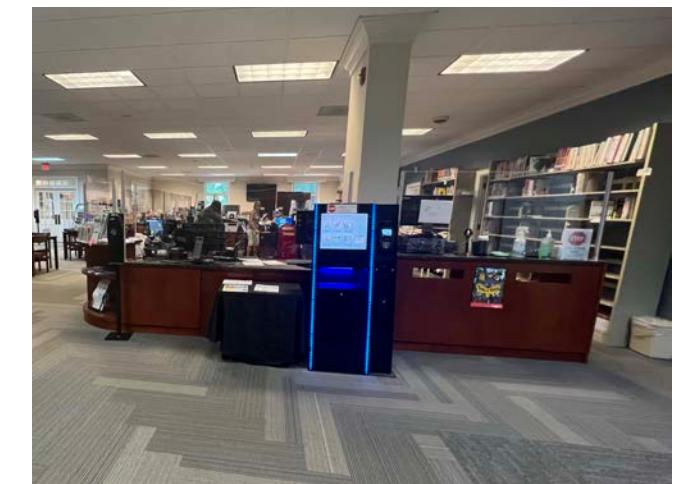
3B Side of circulation desk; book drop opening on the right complies with ADA side approach requirements

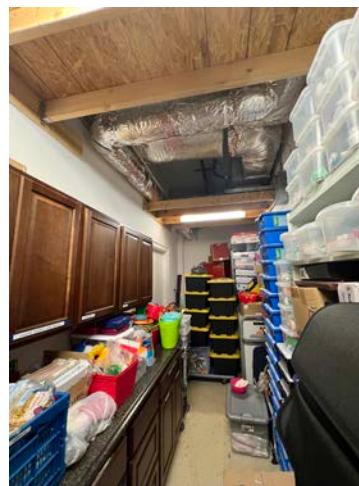
13 Table and chair storage for the community room

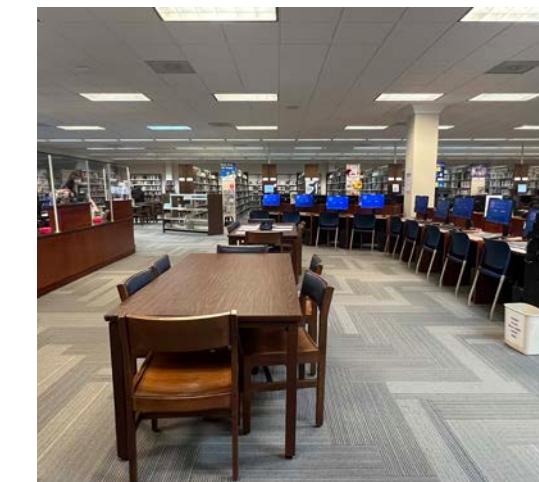
11A Computer area, located in close proximity to circulation desk

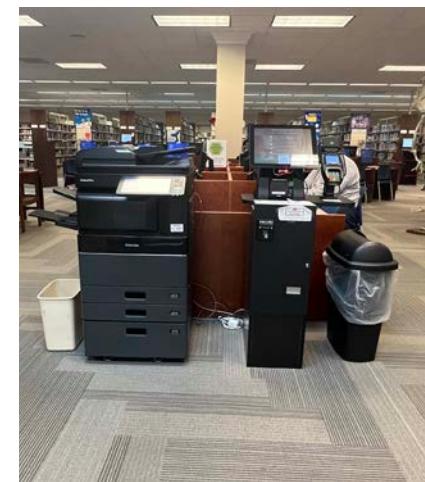
11B Print station is located in close proximity to the computers and circulation desk

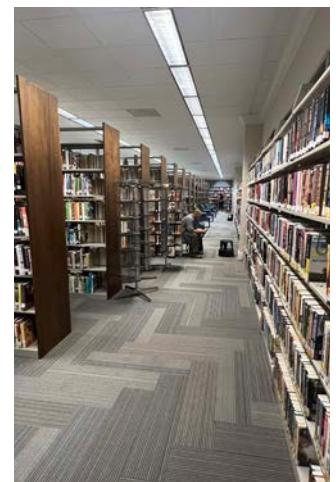
12A Library shelving and aisles

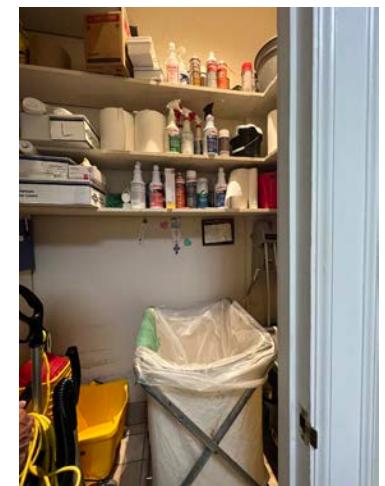
16 Janitor's closet is completely full

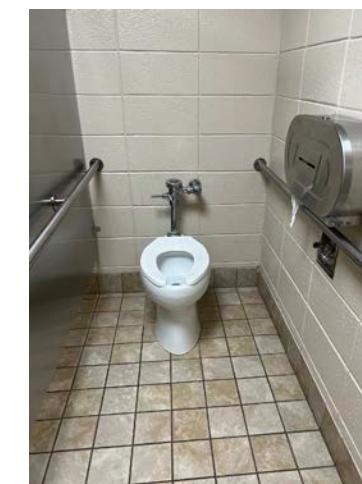
**18** The women's restroom has many code and ADA related issues

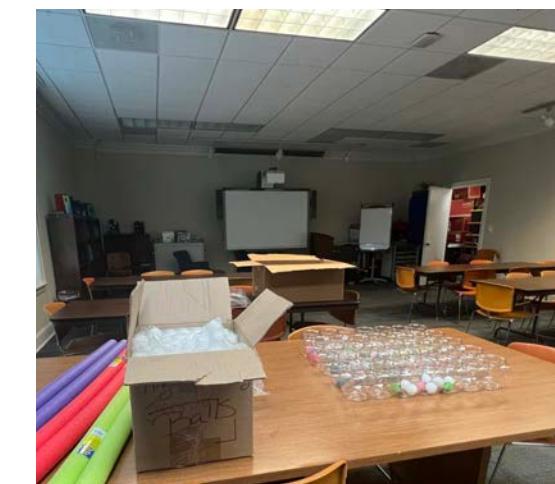
**20** The community room

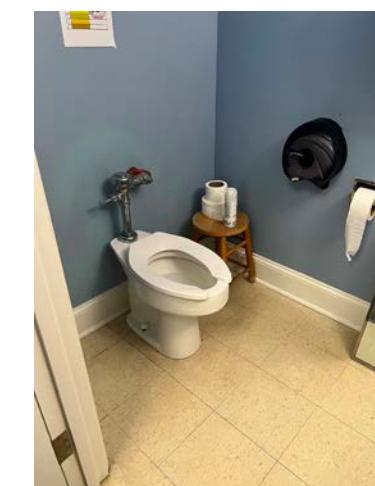
**22A** The staff restroom toilet; this restroom has many code and ADA related issues

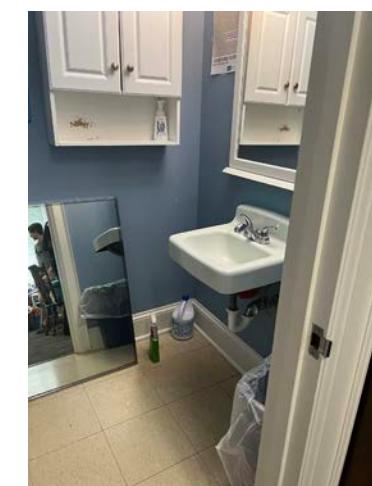
<b>22B</b>	The sink is mounted too low, does not meet ADA requirements, and has exposed piping below. There are no clean-outs provided in the building; whenever the plumbing lines are clogged, facilities must remove the sink to clear the waste lines.
<b>123 WORK ROOM</b>	<b>23</b>	The work room is being used for overflow storage.
<b>124 STORAGE</b>	<b>24</b>	The is a small storage closet for the work room. This room was not observed during the walk through.

**22B** The staff restroom sink

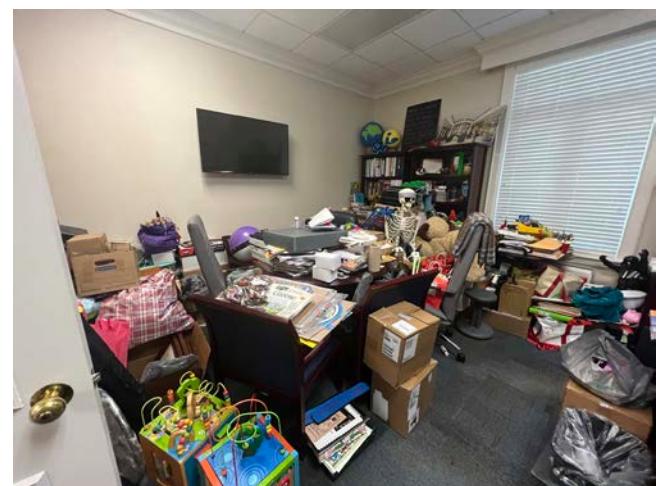
**27** Conference room is being used as additional storage space

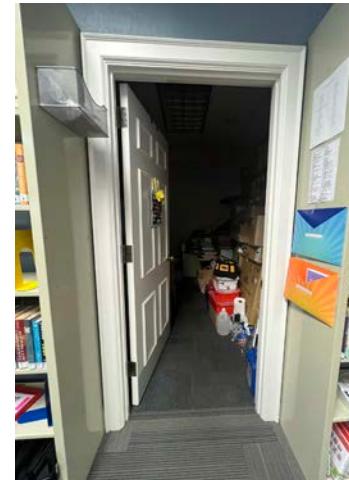
**29A** The office door does not have adequate clearances or room for signage

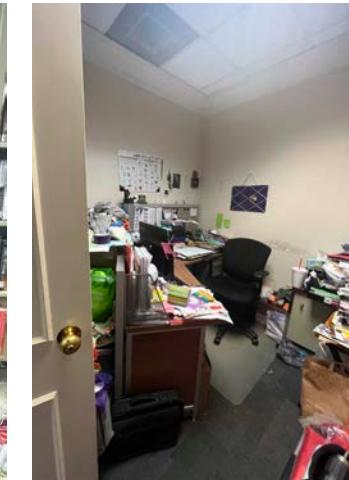
**29B** The office is being used as additional storage space

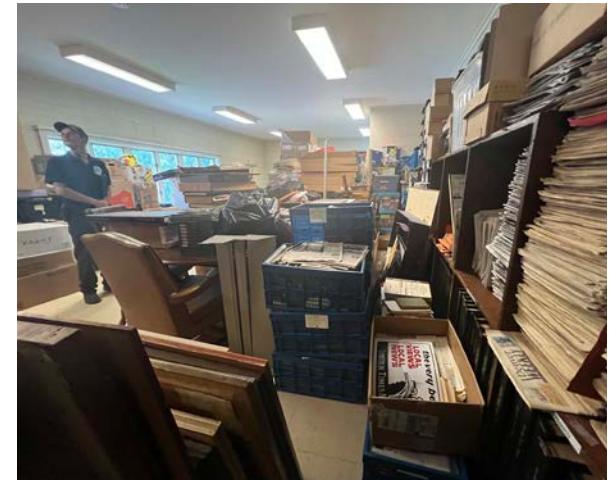
**30** Mezzanine storage area is completely full

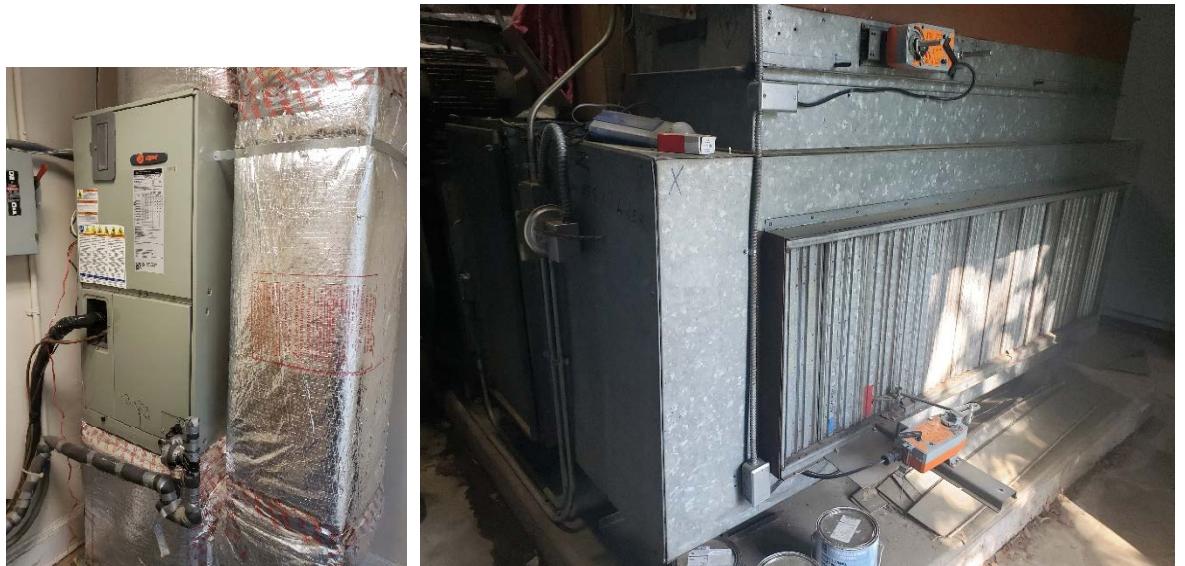
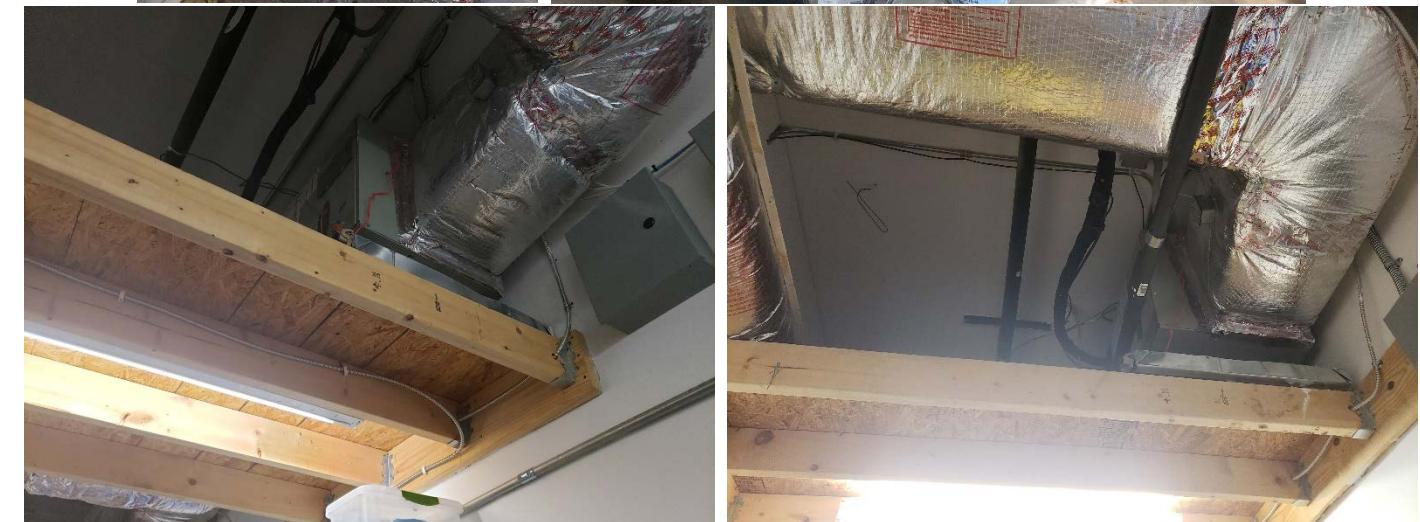
Figure 2: Air Handlers

The large air handling unit was installed in 1978, so is well past useful life. However, replacement has been delayed due to logistical challenges removing the unit from the mechanical room.

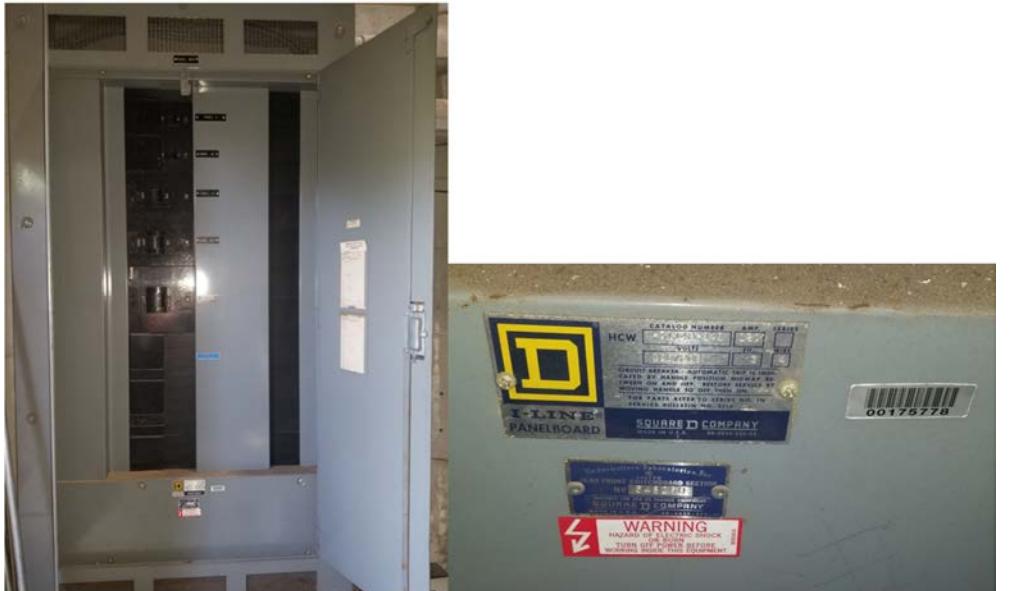
Figure 6: Panel MDP

Panel MDP is a 1200A 208Y/120V, 3-Phase, 4-wire main distribution board feeding all other branch panels in the building. The panel is located in the exterior accessible mechanical closet. Panel MDP service entrance rated disconnect appears to have been removed and does it house a surge protection device as required by NEC 70 and NFPA 780.

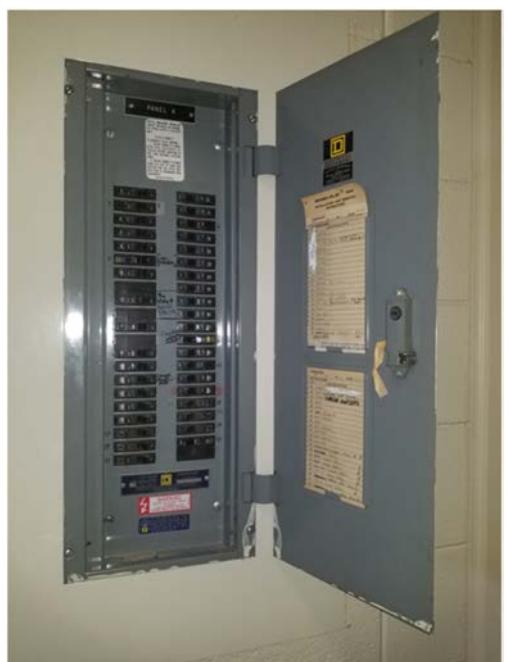
Figure 7: Panel A

Panel A is a 42-pole 100A, 208Y/120V, 3-Phase, 4-wire branch panel manufactured by Square D. All existing breakers are in the "on" position with no spares available. This panel would not be physically capable of supporting any additional circuits.

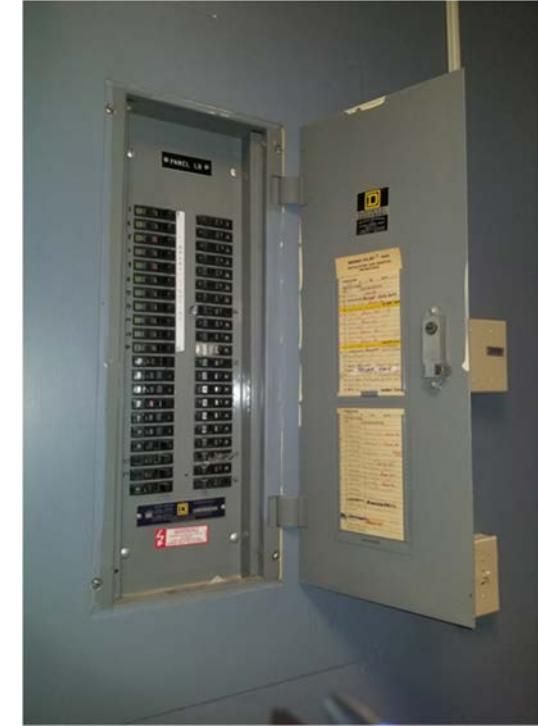
Figure 8: Panel LB

Panel LB is a 42-pole 225A, Main Lugs Only, 208Y/120V, 3-Phase, 4-wire branch panel manufactured by Square D. All existing breakers are in the "on" position with no spares available. This panel would not be physically capable of supporting any additional circuits.

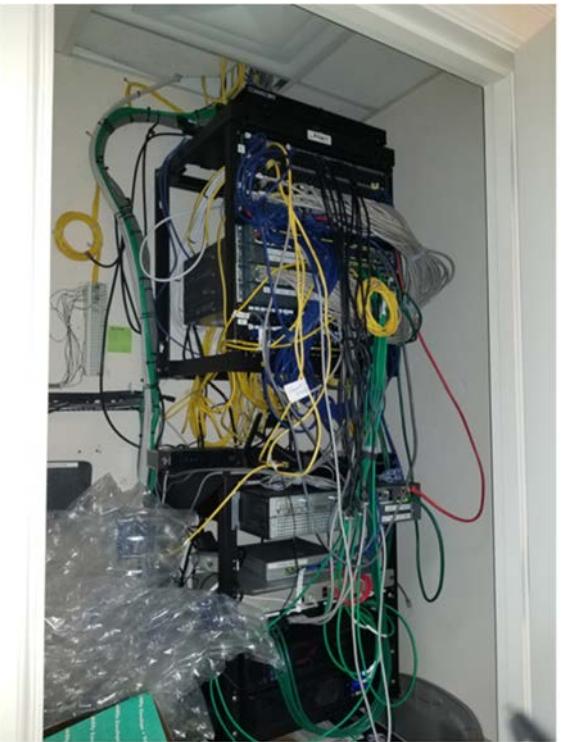
Figure 13: Communications Equipment Rack

The existing communication equipment rack(s) and patch panels are located in a storage closet located in the office area. There does not appear to be clear labeling or cable management provided for the racking system.

A designated low voltage closet with a cable management system for the low voltage equipment is recommended.

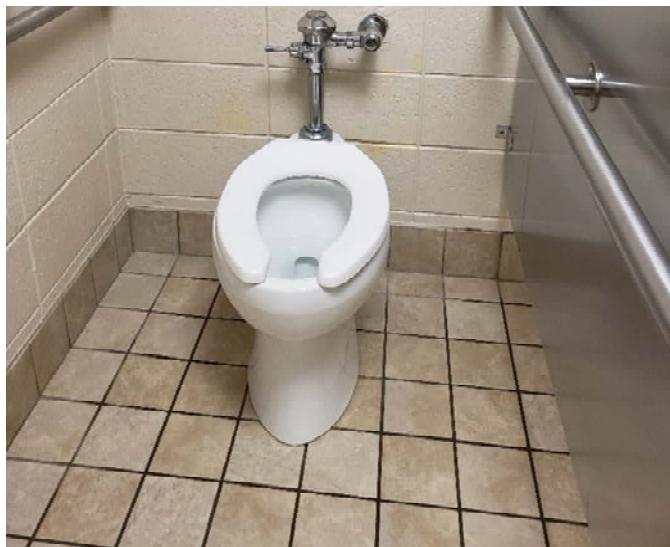
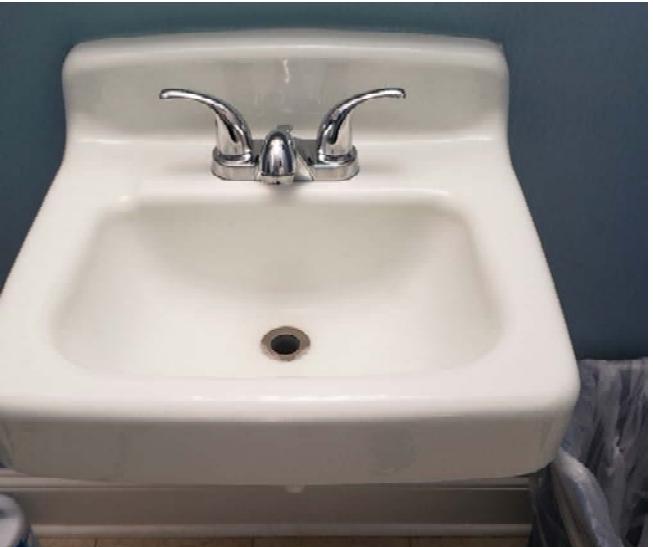
The existing plumbing systems are located in the break room, bathrooms, kitchen, and janitor's closet. It consists of four toilets, one urinal, one mop sink, one floor drain, two lavatories, and a kitchen sink. As the library has an A-3 occupancy classification, restroom lavatory faucets are required to have metering capability, per 2018 NCPC 604.4.1. However, any updates to plumbing fixtures would compel the library to come up to current accessibility codes (2018 NCBC section 11) for ADA clearances and/or protection of piping in bathrooms.

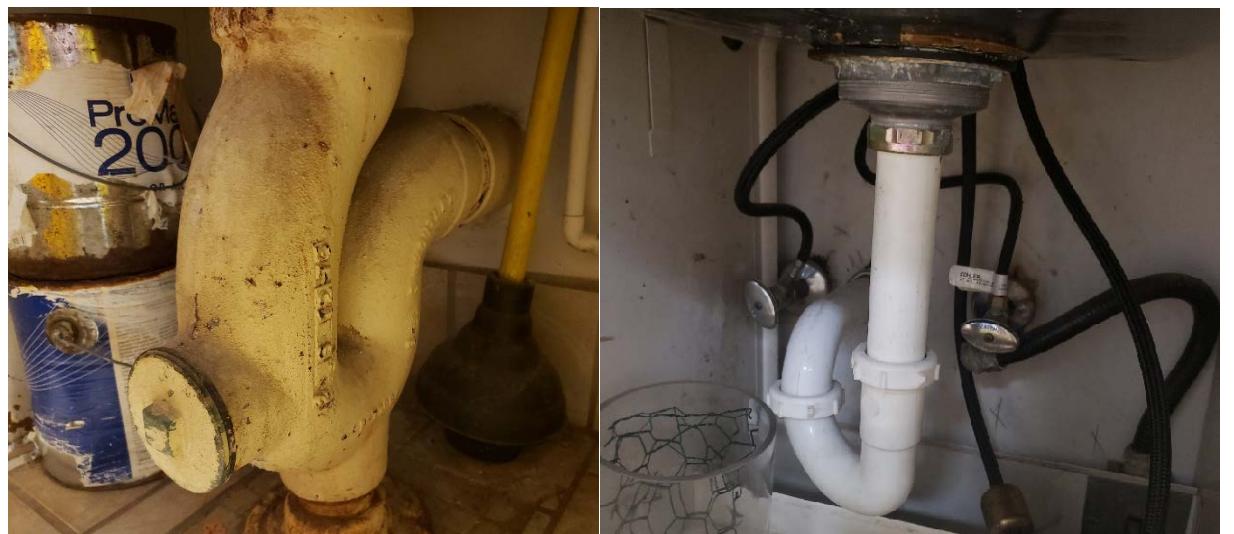
Figure 15: P-Traps

Sanitary traps and vents are in good condition, with toilet lavatories needing minor attention for cleaning and P-trap connection alignment verification. It is noted by observation and per maintenance manager, that no wall cleanouts are present and there are no floor cleanouts within the library.

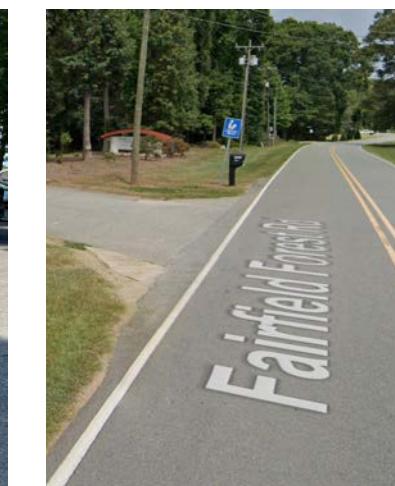
4 A small sign for library parking is provided at the curb cut at Fairfield Forest Rd

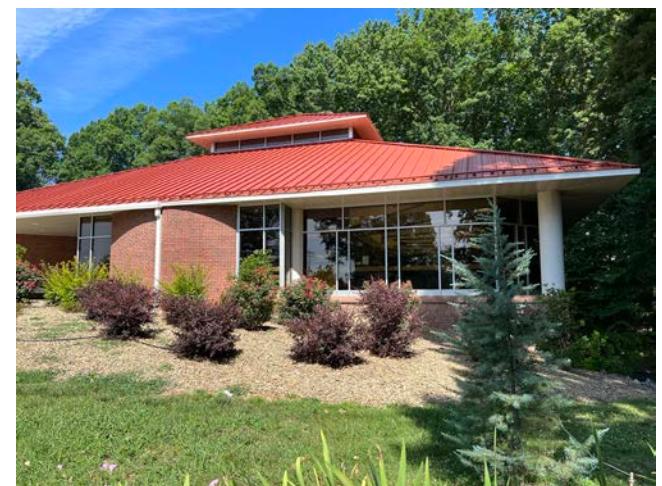
**6B** The plantings around the building appear to be well maintained; the planting beds could use a fresh edge around them

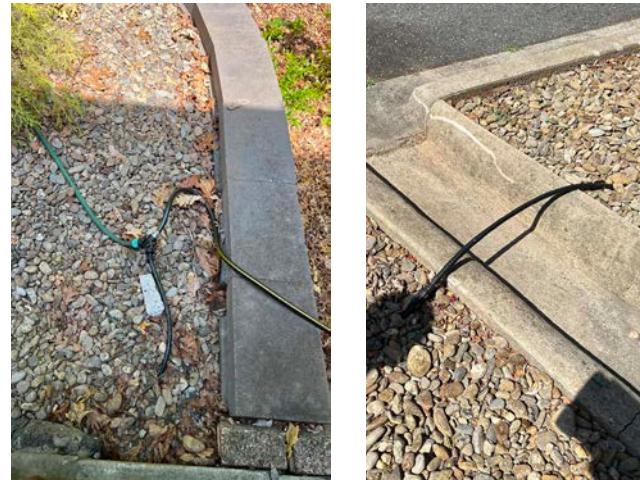
**6C** The irrigation system is visible at some of the planting beds

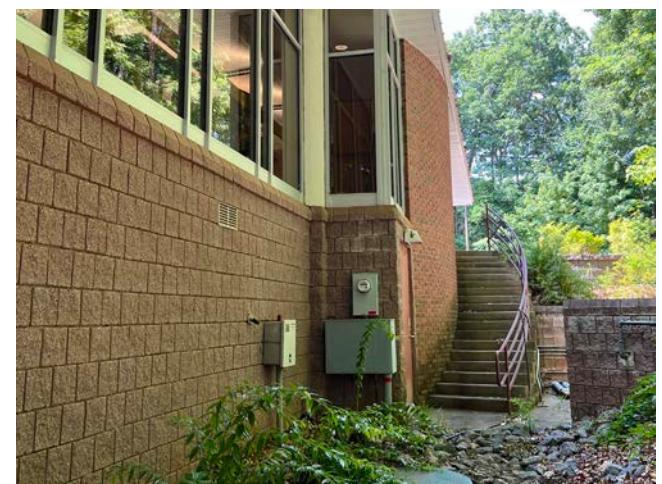
**11** A railing should be installed on the face of the building to comply with current building codes; the existing stair railing could use a fresh coat of paint

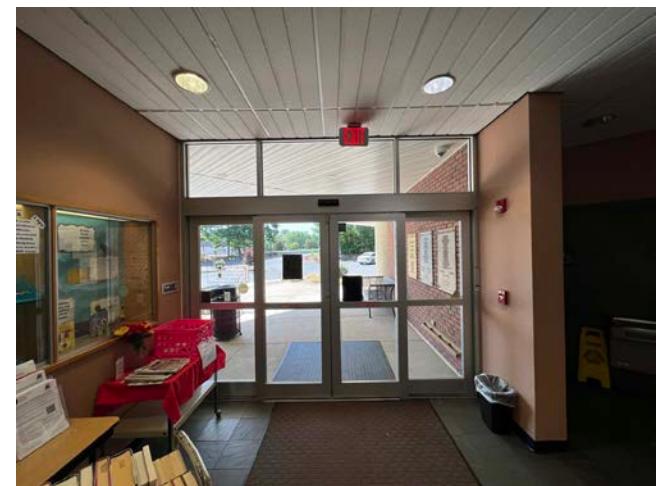
**1C** The sliding doors along the building's accessible route; photo taken from inside of lobby

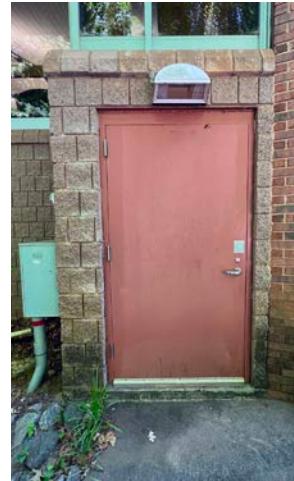
<b>2A</b> Efflorescence at the mechanical room door

<b>2A</b>	Efflorescence is present on the brick around the building. It is mostly prevalent below the finish floor at the crawl space, mechanical room, and retaining wall at the mechanical yard.

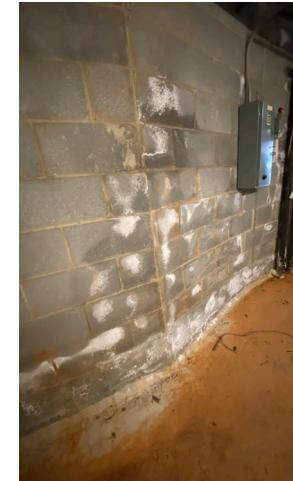
<b>2A</b> Efflorescence on mechanical room wall

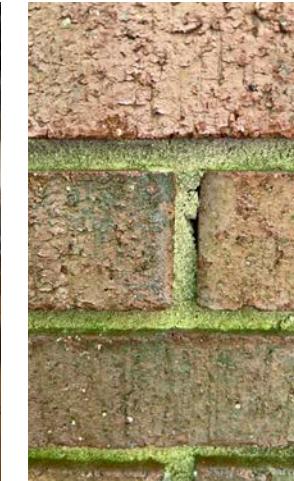
<b>2B</b> Raked mortar joint with moss growth; rake joint creates a ledge that holds water

<b>2B</b>	Raked mortar joints contribute to moisture infiltration, as each joint becomes a ledge that holds water.

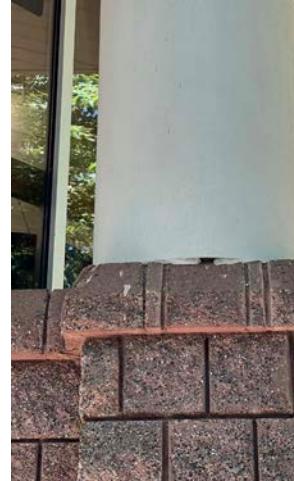
<b>3A</b> Caulking at the north east exterior column needs repaired

<b>3A</b>	Caulking at the north east column needs repaired.

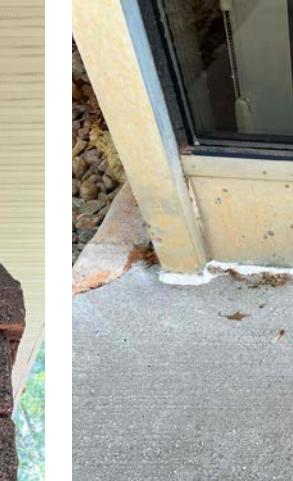
<b>3B</b> Storefront sill at the multipurpose room shows evidence of a prior leak; it appears that the leak was fixed with caulking

<b>3B</b>	Storefront sill at the multipurpose room shows evidence of a prior leak; it appears that the leak was fixed with caulking.

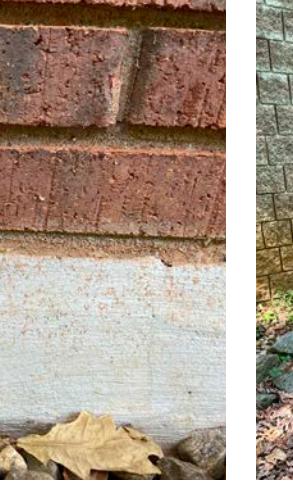
<b>3B</b> Storefront sill at the multipurpose room shows evidence of a prior leak; it appears leak was fixed with caulking

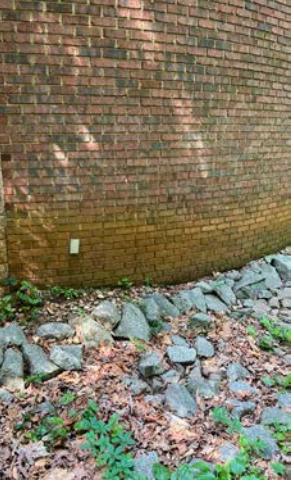
<b>4C</b> No flashing is provided above grade; weep holes appear to be installed post-construction in an attempt to vent the wall cavity

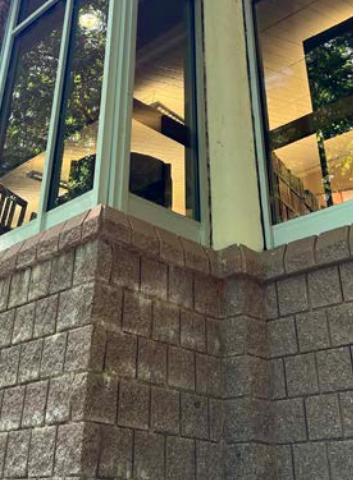
<b>2C</b>	Brick and split face CMU are in need of a good cleaning to remove efflorescence and dirt, particularly at the northern and eastern facades

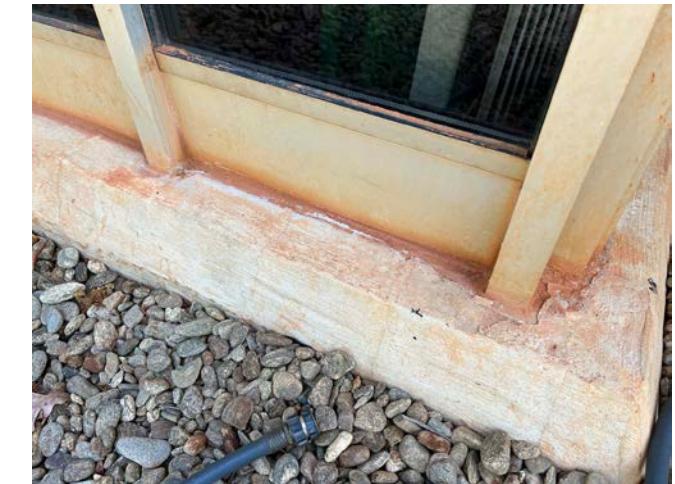
**8A** Storefront is in need of a good cleaning

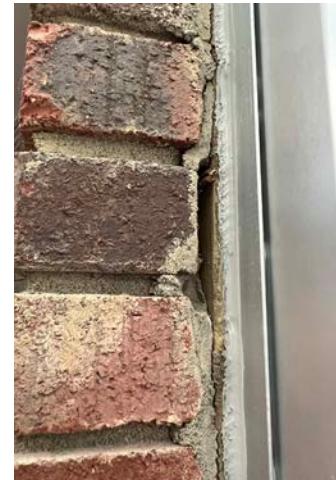
**8C** Wood blocking is visible at storefront jambs

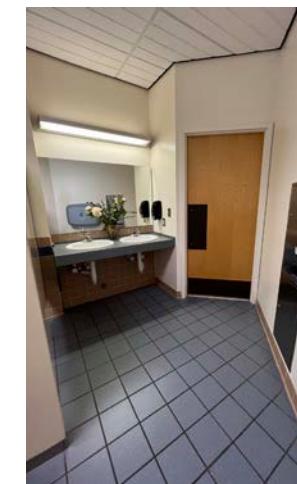
**2A** Exposed pipes at sink

**2C** Inadequate door clearance

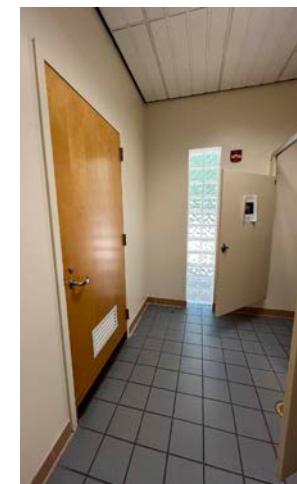
**2B** The door to the ADA stall should have a self-closing door

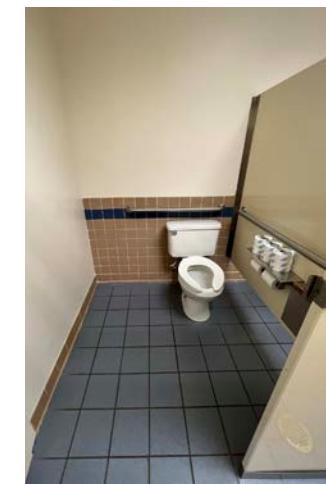
**2D** No vertical grab bar

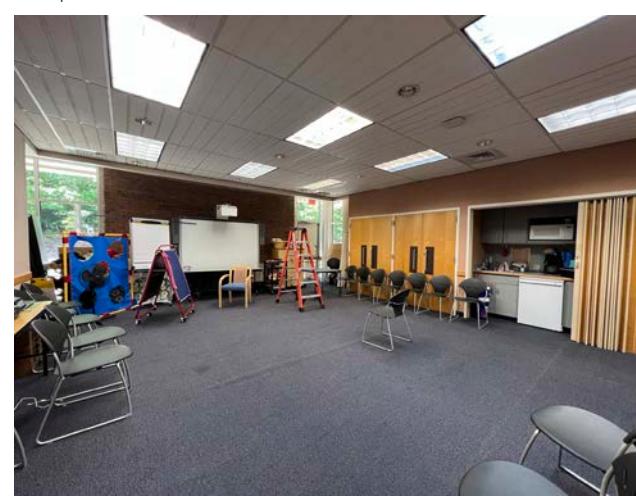
**4A** Multipurpose room carpet is rippling

**7** Accordion partition at kitchenette appears cumbersome

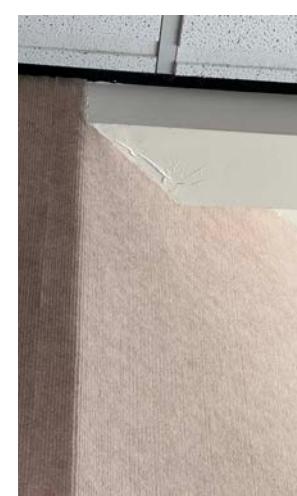
<b>4C</b>	Evidence of water damage is present at the tackable wall covering, soffit, and ceiling tiles. Facilities mentioned that the dormers that have since been demolished used to leak.
	<b>4D</b>	Tackable wall covering adhesive has released, and the wall covering is now bubbled and pulling away from the wall.
<b>105 STORAGE</b>	<b>5</b>	Multipurpose room storage is at capacity.
<b>106 SUPPLY STORAGE</b>	<b>6</b>	Multipurpose room storage is at capacity.
<b>107 KITCHENETTE</b>	<b>7</b>	Kitchenette is at capacity; accordion partition appears cumbersome. Carpet at a wet location is not ideal.

**4C** Water damage at soffit

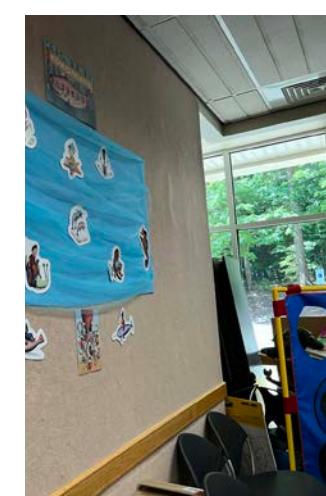
**4D** Wall cover is bubbling and pulling away from the wall

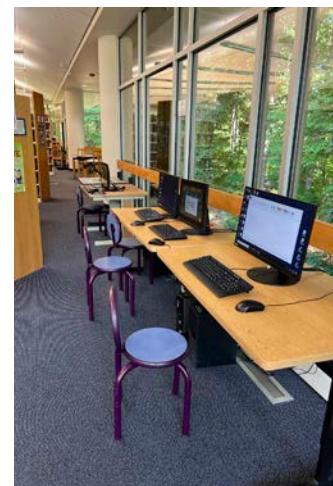
**15A** Children's computer stations are too tall for younger children

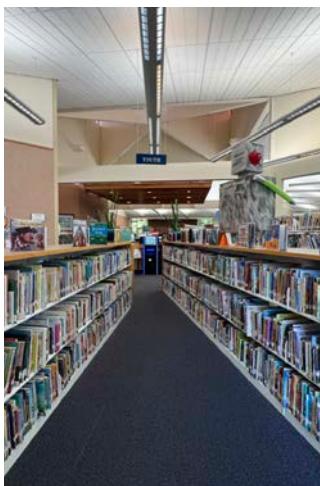
**15B** Children's area signage; shelving layout is inefficient

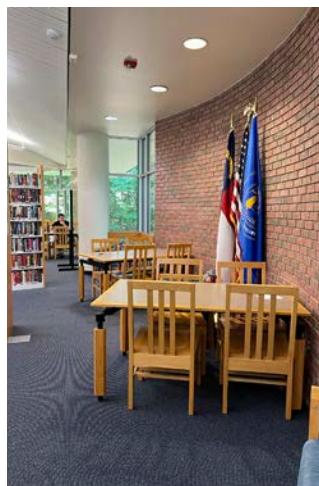
**15C** Inefficient shelving layout leaves little space for library seating; seating areas have limited power outlets

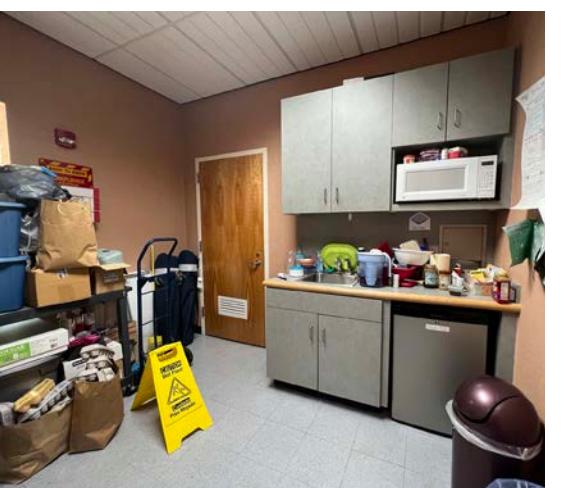
**10** The break room is currently being used as overflow storage space; the kitchenette area is at capacity and appears to be undersized

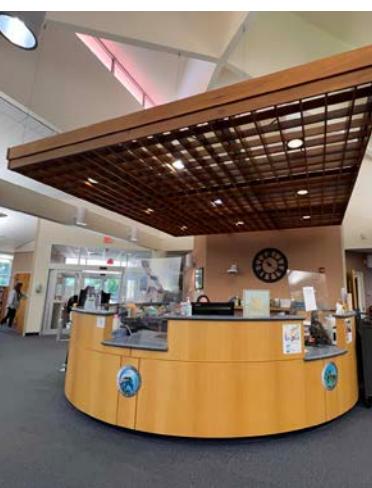
**14A** Book carts should be parked further from the ADA transaction area to allow for adequate clearances

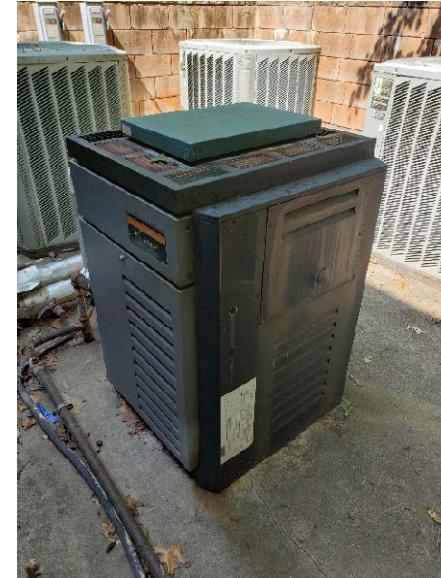
Figure 2: Hot Water Boiler

For heating, the building uses a 22-ton hot water boiler, which is also at the end of its useful life, and shows signs of wear and tear (rusting).

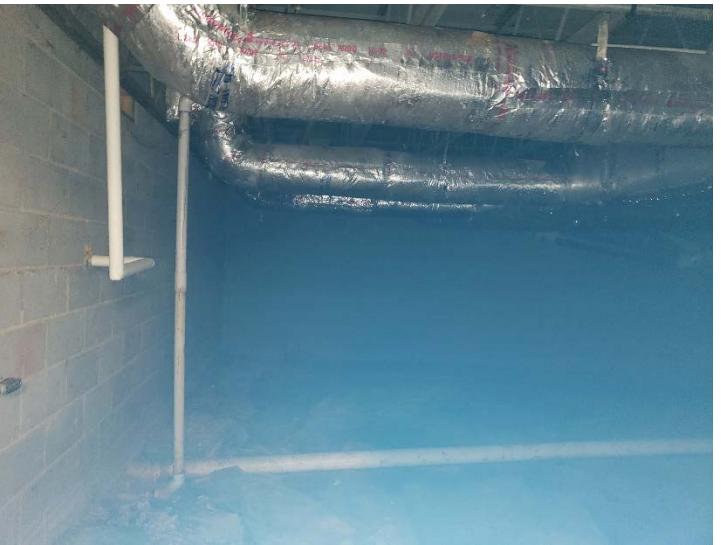
Figure 5: Basement Ductwork

All supply and return air ductwork off the units are insulated sheet metal ductwork with insulated flex duct coming off the branches to the supply diffusers and return grilles..

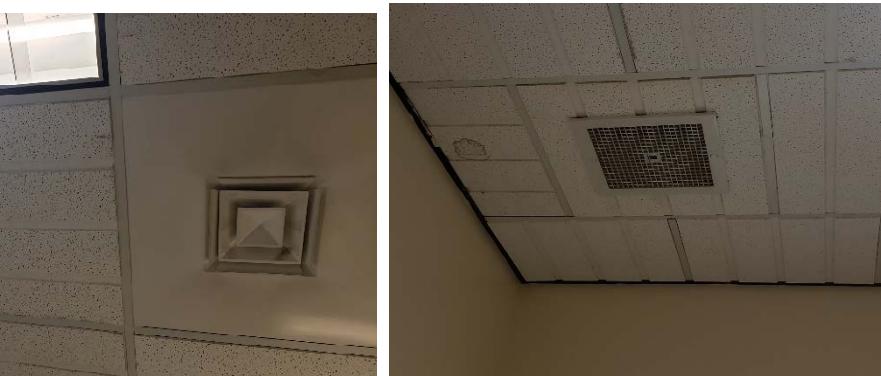
Figure 6: Diffusers (Typical)

Diffusers meet current standards, varying depending on area. All diffusers are metal, off-white, or painted to match the service area walls. See Figure 4 below.

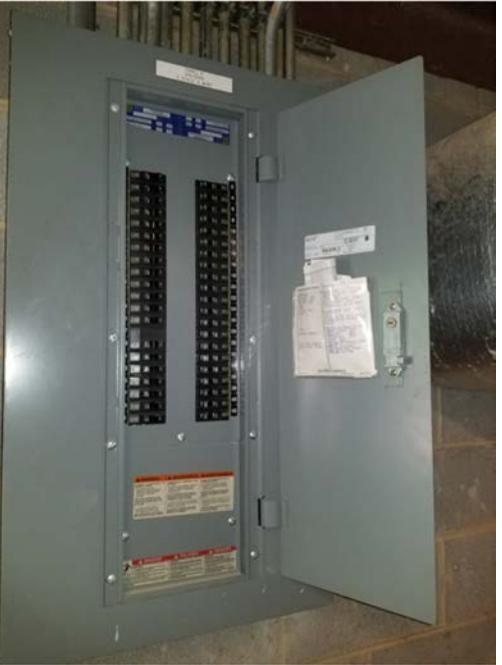
Figure 9: Panel R

Panel R is a 42-pole 100A, 208Y/120V, 3-Phase, 4-wire branch panel manufactured by Square D. The panel is located in the electrical/ utility close on the main floor. All existing breakers are in the "on" position with no spares available. This panel would not be physically capable of supporting any additional circuits - all existing breakers currently feed existing loads.

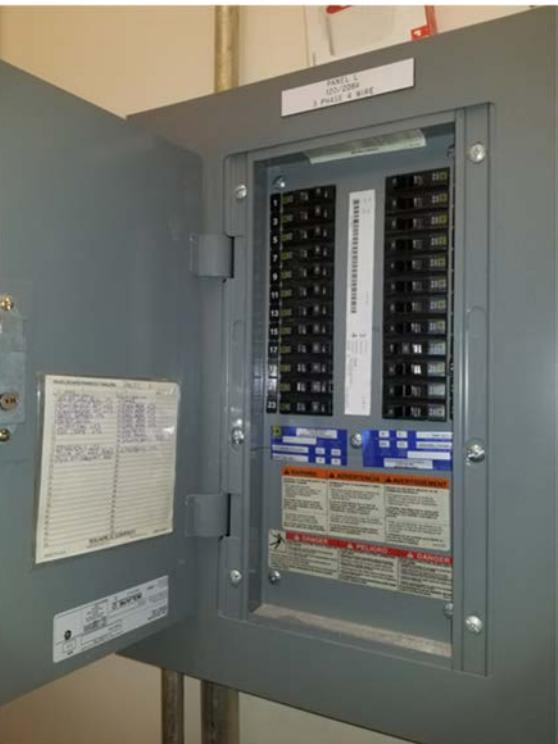
Figure 10: Panel L

Panel L is a 24-pole 100A, 208Y/120V, 3-Phase, 4-wire branch panel manufactured by Square D. The panel is located in the electrical/ utility close on the main entry level. All existing breakers are in the "on" position with no spares available. This panel would not be physically capable of supporting any additional circuits - all existing breakers currently feed existing loads.
