FACILITY ASSESSMENT AND SPATIAL PLANNING

# LINCOLN COUNTY PUBLIC LIBRARIES

ISSUE DATE: OCTOBER 6, 2022

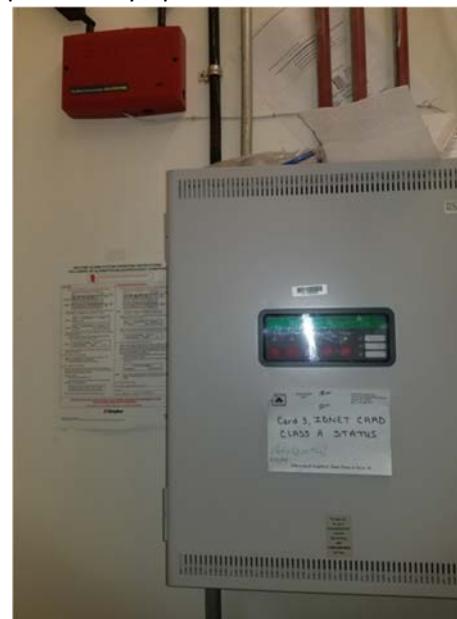
Figure 11: Fire Alarm Panel

There is an existing fire alarm system present. The control panel is located in the electrical/utility closet on the main entry level. Shop drawings and coordination with the manufacturer/ provider of the existing system will be required to determine existing systems limits and expandability options.

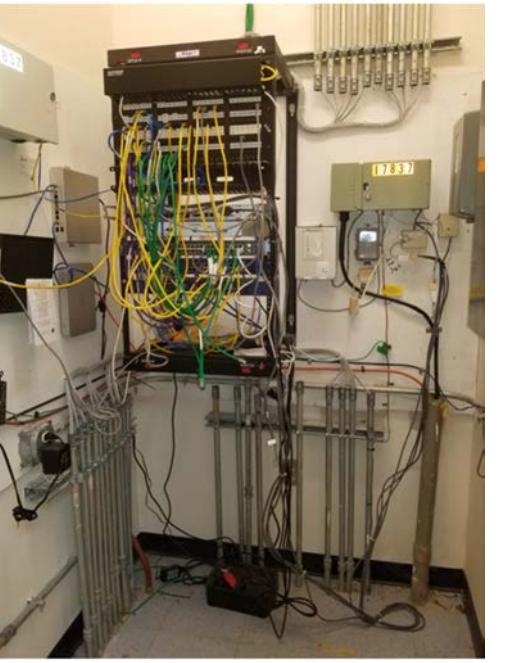
Figure 12: Communication Equipment

The existing communications entry, equipment rack(s) and patch panels are located in the electrical/utility closet on the main entry level. There does not appear to be clear labeling or cable management provided for the racking system.

Cable management for the low voltage equipment is recommended.

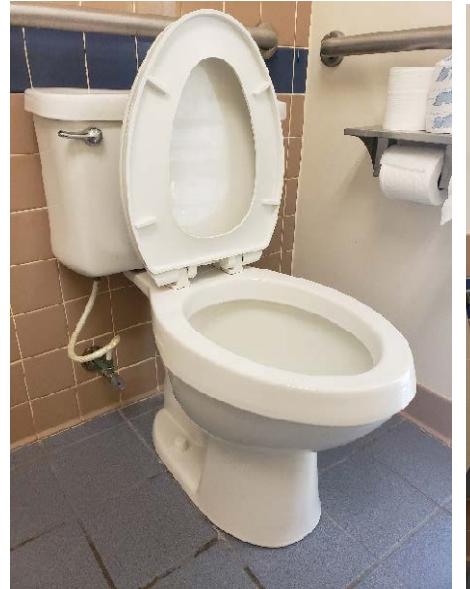
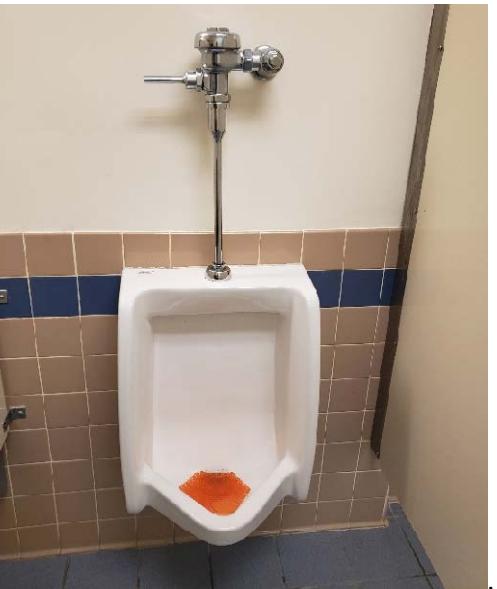
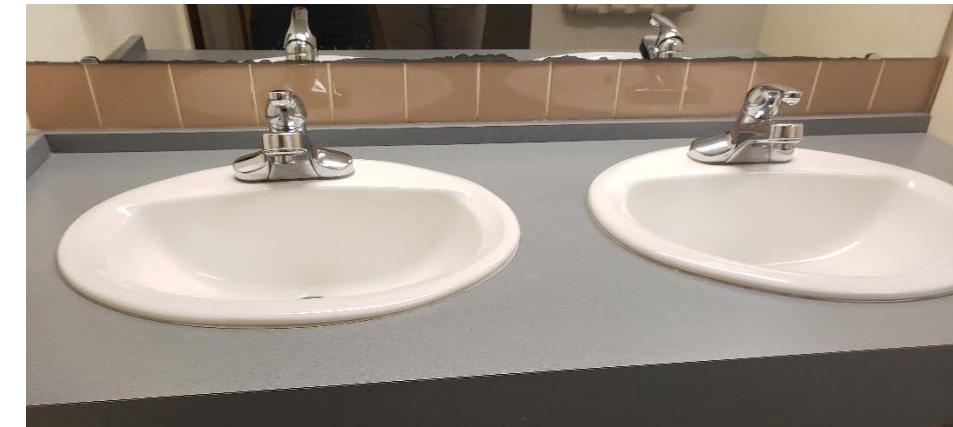
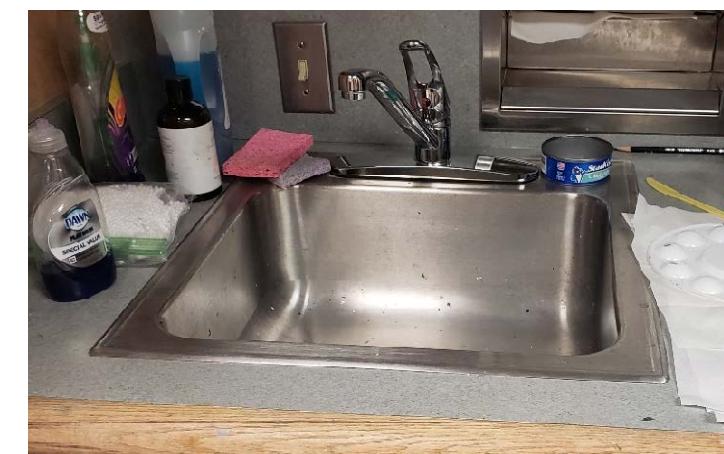
Figure 13: Plumbing Fixtures

The existing plumbing systems are located in the break room, bathrooms, kitchen, and janitor's closet. It consists of four toilets, one urinal, one mop sink, one floor drain, five lavatories, and two kitchen sinks. As the library has an A-3 occupancy classification, restroom lavatory faucets are required to have metering capability, per 2018 NCPC 604.4.1. However, any updates to plumbing fixtures would compel the library to come up to current accessibility codes (2018 NCBC section 11) for ADA clearances and/or protection of piping in bathrooms.

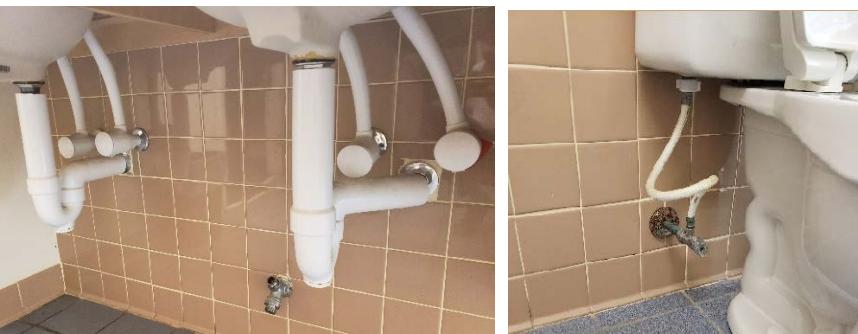
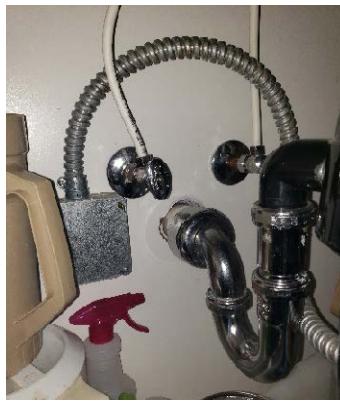
Figure 18: P-Traps

Sanitary traps are and vents are in good condition, while the sump pump is in fair condition, though nearing the end of life (per maintenance, the sump pump was installed at the high side instead of the low side). In the restrooms, ADA required protection is in place.
